# Access Compliance Report

## Public Rights-of-Way

### (Curb Ramps)

Intersection ID: 24360	Main Street: BIRNEN_DR	Cross Street: ESSEN_LN	Location: NW
ADA ID: AB594B1678C8	Ramp Type: PerpDiag	Initial Pass/Fail: Fail	Overall Compliance: No
		Severity Score: 22.5

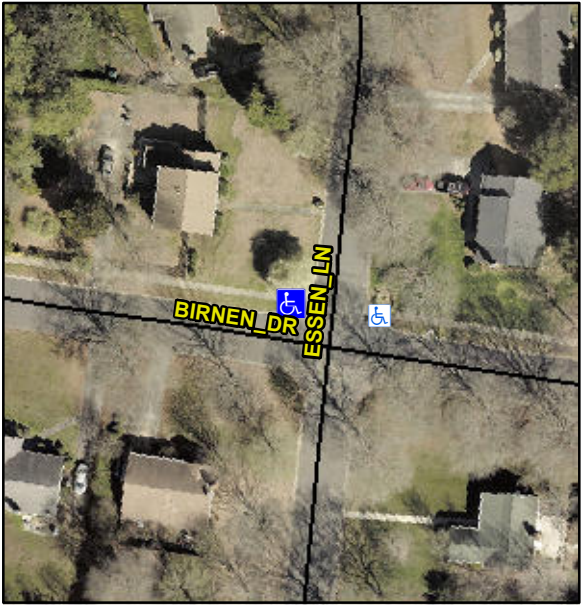
Possible Solutions:		<b>Compliance</b>	<b>Description</b>	<b>Data</b>
	<b>Remove &amp; Replace Curb Ramp With Two New Directional Ramps or Equivalent.</b>		<b>No</b>	Ramp Length (in)	77.0
			<b>No</b>	Ramp Width (in)	45.0
			<b>N/A</b>	Flare Type LT	N/A
			<b>N/A</b>	Flare Slope LT (%)	N/A
			<b>N/A</b>	Flare Traversable LT?	N/A
			<b>N/A</b>	Landing Length (in)	N/A
			<b>N/A</b>	Landing Width (in)	N/A
			<b>N/A</b>	Landing Slope (%)	N/A
			<b>N/A</b>	Landing X Slope (%)	N/A
<p>Surveyor Notes:</p> <p><b>N/A</b></p> <p>PROW/ADA:</p> <p><b>Not Found, R304.5.1, R304.2.2, R304.5.3</b></p>			<b>N/A</b>	Flare Type RT	N/A
			<b>N/A</b>	Flare Slope RT (%)	N/A
			<b>N/A</b>	Flare Traversable RT?	N/A
			<b>N/A</b>	DWS Provided?	N/A
			<b>N/A</b>	DWS Contrast?	N/A
			<b>N/A</b>	DWS Length (in)	N/A
			<b>N/A</b>	DWS Full Width?	N/A
