Access Compliance Report

Public Rights-of-Way

(Curb Ramps)

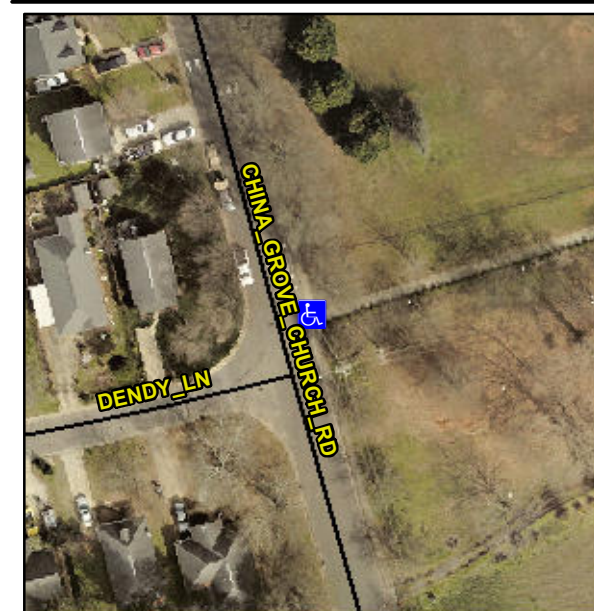
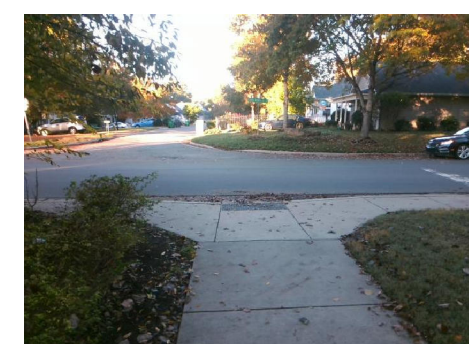
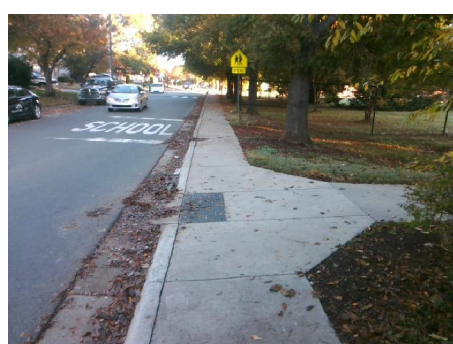
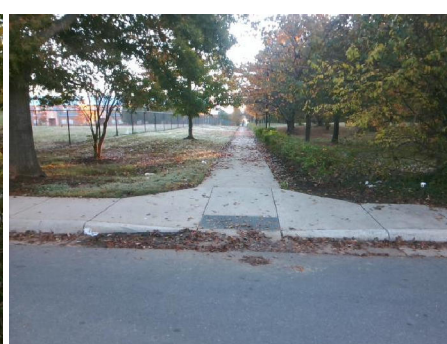
Intersection ID: 24277	Main Street: CHINA GROVE CHURCH RD	Cross Street: DENDY LN	Location:	NE
ADA ID: AB5DE4A3CC48	Ramp Type: Perp	Initial Pass/Fail: Pass	Overall Compliance: No	Severity Score: 7.5
Codes/Mitigation Info/Possible Solution		Field Measurements/Component Compliance

**Not Found, R304.2.2-Perp, R304.3.2-
Para, R302.7.2, R304.5.3**

Compliance	Description	Data	Compliance	Description	Data
N/A	Ramp Length (in)	97.0	Yes	Ramp Slope (%)	5.5
Yes	Ramp Width (in)	48.5	Yes	Ramp XSlope (%)	1.8
N/A	Flare Type LT	Sloped	N/A	Flare Type RT	N/A
N/A	Flare Slope LT (%)	6.9	Yes	Flare Slope RT (%)	4.1
N/A	Flare Traversable LT?	Yes	N/A	Flare Traversable RT?	Yes
Yes	Landing Length (in)	60.0	Yes	DWS Provided?	Yes
Yes	Landing Width (in)	71.0	Yes	DWS Contrast?	Yes
No	Landing Slope (%)	3.3	Yes	DWS Length (in)	24.0
Yes	Landing X Slope (%)	1.0	Yes	DWS Full Width?	Yes
N/A	Landing Curb? (Y/N)	No	Yes	DWS Offset (in)	0.0
N/A	Shared Landing?	No			
Yes	Gutter Ponding?	No	Yes	Gutter Slope (%)	0.7
No	Gutter Lip Ht (in)	0.5	No	Gutter X Slope (%)	3.2
N/A	Painted X Walk1?	No	N/A	Painted X Walk2?	N/A
	X Walk 1 Direction	To W		X Walk 2 Direction	N/A
N/A	X Walk 1 Width (in)	N/A	N/A	X Walk 2 Width (in)	N/A
	X Walk 1 Slope (%)	1.5		X Walk 2 Slope (%)	N/A
	X Walk 1 X Slope (%)	1.8		X Walk 2 X Slope (%)	N/A

N/A	Ramp inside XWalk1?	N/A	N/A	Ramp inside XWalk2?	N/A
	Road Slope (%)	N/A	N/A	Clear Space?	Yes
	Road X Slope (%)	N/A	N/A	Clear Space to XWalk (in)	N/A
Yes	Any Obstructions?	No	Yes	Storm Grate/Utility Hazard?	No
	Obstruction Type			Storm Grate/Utility Type	
		N/A			N/A
			Yes	Surface Condition? (G/P)	Good

**Remove & Replace Entire Ramp.
Remove & Replace Gutter.**
