Access Compliance Report Public Rights-of-Way (Curb Ramps)

Intersection ID: 43757 Main Street: DERVISH_LN Cross Street: ZIEGLER_LN Location: N

ADA ID: ABB564EDCC8D Ramp Type: PerpDiag Initial Pass/Fail: Fail Overall Compliance: No Severity Score: 33.75

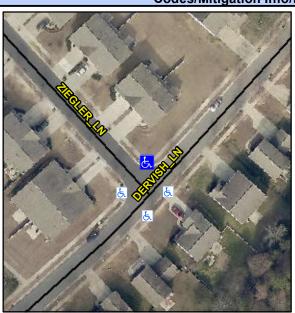
Not Found, R304.5.1, R304.2.2,

Field Measurements/Component Compliance						
	Compliance Description		Data	Compliance Description		Data
	N/A	Ramp Length (in)	46.5	No	Ramp Slope (%)	10.5
	No	Ramp Width (in)	46.0	No	Ramp XSlope (%)	5.7
	N/A	Flare Type LT	N/A	N/A	Flare Type RT	N/A
	N/A	Flare Slope LT (%)	N/A	N/A	Flare Slope RT (%)	N/A
	N/A	Flare Traversable LT?	N/A	N/A	Flare Traversable RT?	N/A
	N/A	Landing Length (in)	N/A	N/A	DWS Provided?	N/A
	N/A	Landing Width (in)	N/A	N/A	DWS Contrast?	N/A
	N/A	Landing Slope (%)	N/A	N/A	DWS Length (in)	N/A
	N/A	Landing X Slope (%)	N/A	N/A	DWS Full Width?	N/A
	N/A	Landing Curb? (Y/N)	N/A	N/A	DWS Offset (in)	N/A
	N/A	Shared Landing?	N/A			
	N/A	Gutter Ponding?	N/A	N/A	Gutter Slope (%)	N/A
	N/A	Gutter Lip Ht (in)	1.0	N/A	Gutter X Slope (%)	N/A
	N/A	Painted X Walk1?	No	N/A	Painted X Walk2?	No
		X Walk 1 Direction	To SW		X Walk 2 Direction	To SE
	N/A	X Walk 1 Width (in)	N/A	N/A	X Walk 2 Width (in)	N/A
		X Walk 1 Slope (%)	0.2		X Walk 2 Slope (%)	6.2

X Walk 1 X Slope (%)	3.8		X Walk 2 X Slope (%)	5.0
	N/A	Ramp inside XWalk1?	N/A	N/A	Ramp inside XWalk2?	N/A
		Road Slope (%)	5.0	N/A	Clear Space?	N/A
		Road X Slope (%)	3.3	N/A	Clear Space to XWalk (in)	N/A
	N/A	Any Obstructions?	N/A	N/A	Storm Grate/Utility Hazard?	N/A
		Obstruction Type		l	Storm Grate/Utility Type	
			N/A			N/A
				Yes	Surface Condition? (G/P)	Good

Remove & Replace Curb Ramp With Two New Directional Ramps or Equivalent.
