Access Compliance Report

Public Rights-of-Way

(Curb Ramps)

Intersection ID: 12274	Main Street: BERRYHILL_RD	Cross Street: MORTON_ST	Location: NE
ADA ID: AC27698904BD	Ramp Type: Combination1Diag	Initial Pass/Fail: Fail	Overall Compliance: No
		Severity Score: 0

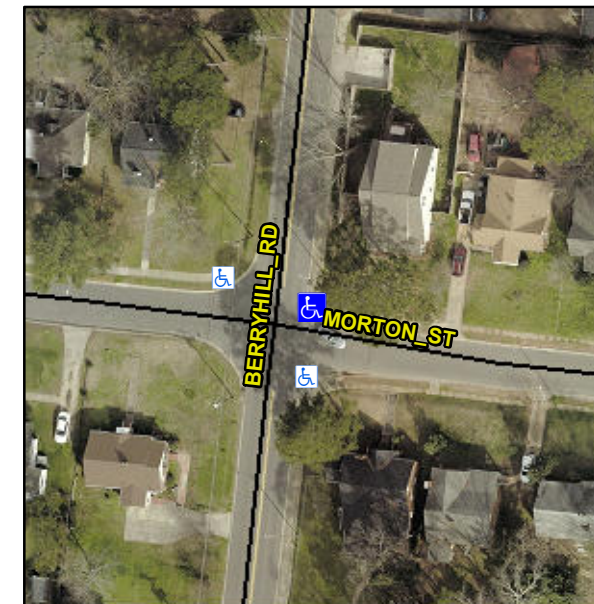
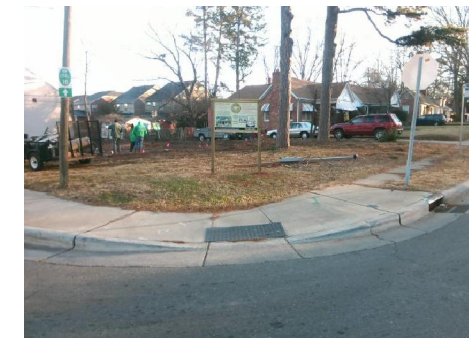
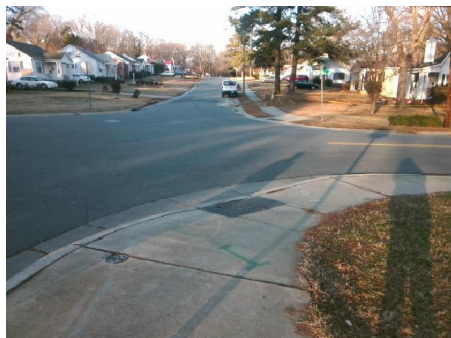
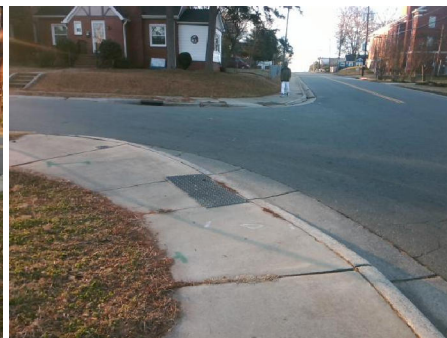
LT RP < 5%

Not Found, R304.5.1, R304.5.3, R304.3.2

Compliance	Description	Data	Compliance	Description	Data
N/A	Ramp Length LT (in)	55.0	N/A	Ramp Length RT (in)	56.0
Yes	Ramp Width LT (in)	60.0	Yes	Ramp Width RT (in)	67.0
Yes	Ramp Slope LT (%)	4.1	No	Ramp Slope RT (%)	11.3
No	Ramp XSlope LT (%)	4.5	Yes	Ramp XSlope RT (%)	1.8
N/A	Ramp Length (in)	60.0	Yes	Ramp Slope (%)	5.0
No	Ramp Width (in)	33.0	No	Ramp XSlope (%)	6.1
N/A	Flare Type LT	N/A	N/A	Flare Type RT	N/A
N/A	Flare Slope LT (%)	N/A	N/A	Flare Slope RT (%)	N/A
N/A	Flare Traversable LT?	N/A	N/A	Flare Traversable RT?	N/A
N/A	Landing Length (in)	N/A	N/A	DWS Provided?	N/A
N/A	Landing Width (in)	N/A	N/A	DWS Contrast?	N/A
N/A	Landing Slope (%)	N/A	N/A	DWS Length (in)	N/A
N/A	Landing X Slope (%)	N/A	N/A	DWS Full Width?	N/A
N/A	Landing Curb? (Y/N)	N/A	N/A	DWS Offset (in)	N/A
N/A	Shared Landing?	N/A			
N/A	Gutter Ponding?	N/A	N/A	Gutter Slope (%)	N/A
N/A	Gutter Lip Ht (in)	N/A	N/A	Gutter X Slope (%)	N/A
N/A	Painted X Walk1?	No	N/A	Painted X Walk2?	No

Remove & Replace Curb Ramp With Two New Directional Ramps or Equivalent.
