Access Compliance Report

Public Rights-of-Way

| Intersection ID: 14278 | Main Street: ROMARE_BEARDEN_DR | Cross Street: FARMER_ST | Location: SE |
| ADA ID: AD12077A3A33 | Ramp Type: Perp | Initial Pass/Fail: Fail | Overall Compliance: No |

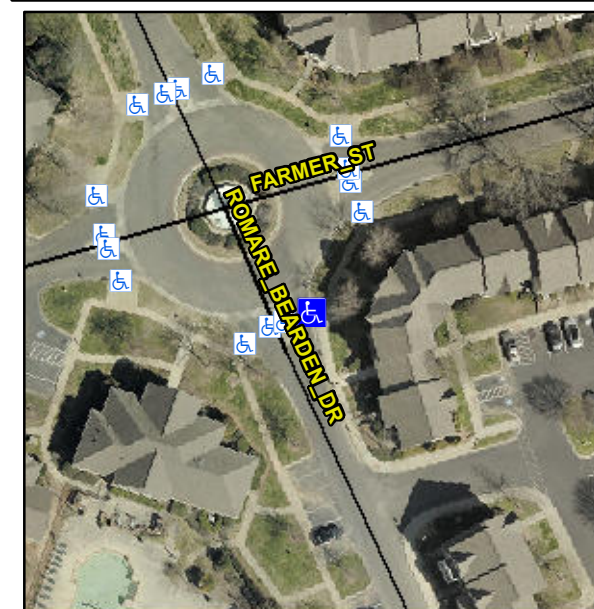
| Severity Score: 1.25 | | | |

R304.5.3

| Compliance | Description | Data | Compliance | Description | Data |
|---|---|---|---|---|---|
| Yes | Ramp Width (in) | 53.0 | No | Ramp XSlope (%) | 3.0 |

Remove & Replace Entire Ramp.
