Access Compliance Report Public Rights-of-Way (Curb Ramps)

Intersection ID: 10829 Main Street: E_34TH_ST Cross Street: HOLT_ST Location: N

ADA ID: AD50AAC39758 Ramp Type: Perp Initial Pass/Fail: Fail Overall Compliance: No Severity Score: 21.25

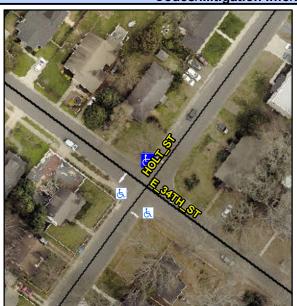
r leid Measurements/Component Compnance								
Compliance Description		Data	Compliance Description		Data				
	N/A	Ramp Length (in)	55.0	No	Ramp Slope (%)	11.2			
	No	Ramp Width (in)	47.5	Yes	Ramp XSlope (%)	2.0			
	N/A	Flare Type LT	N/A	N/A	Flare Type RT	N/A			
	N/A	Flare Slope LT (%)	N/A	N/A	Flare Slope RT (%)	N/A			
	N/A	Flare Traversable LT?	N/A	N/A	Flare Traversable RT?	N/A			
	N/A	Landing Length (in)	N/A	N/A	DWS Provided?	N/A			
	N/A	Landing Width (in)	N/A	N/A	DWS Contrast?	N/A			
	N/A	Landing Slope (%)	N/A	N/A	DWS Length (in)	N/A			
	N/A	Landing X Slope (%)	N/A	N/A	DWS Full Width?	N/A			
	N/A	Landing Curb? (Y/N)	N/A	N/A	DWS Offset (in)	N/A			
	N/A	Shared Landing?	N/A						
	N/A	Gutter Ponding?	N/A	N/A	Gutter Slope (%)	N/A			
	N/A	Gutter Lip Ht (in)	N/A	N/A	Gutter X Slope (%)	N/A			
	N/A	Painted X Walk1?	No	N/A	Painted X Walk2?	N/A			
		X Walk 1 Direction	To SW		X Walk 2 Direction	N/A			
	N/A	X Walk 1 Width (in)	N/A	N/A	X Walk 2 Width (in)	N/A

X Walk 1 Slope (%)	2.1		X Walk 2 Slope (%)	N/A			
		X Walk 1 X Slope (%)	2.7		X Walk 2 X Slope (%)	N/A			
	N/A	Ramp inside XWalk1?	N/A	N/A	Ramp inside XWalk2?	N/A			
		Road Slope (%)	N/A	N/A	Clear Space?	N/A			
		Road X Slope (%)	N/A	N/A	Clear Space to XWalk (in)	N/A			
	N/A	Any Obstructions?	N/A	N/A	Storm Grate/Utility Hazard?	N/A			
		Obstruction Type			Storm Grate/Utility Type

Possible Solutions:						
Remove & Replace Entire Ramp.						
	١					
Surveyor Notes:						
N/A						
PROW/ADA:						
Not Found, R304.5.1, R304.2.2
