## **Access Compliance Report Public Rights-of-Way** (Curb Ramps)

Intersection ID: 23581 Main Street: BRANDON FOREST DR **Cross Street: DRYDEN LN** Location: NE ADA ID: AD9CEC2F1D6D Ramp Type: PerpDiag Initial Pass/Fail: Fail **Overall Compliance: No Severity Score:** 12.5

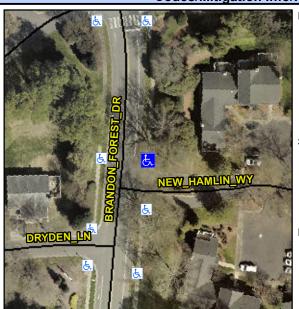
Field Measurements/Component Compliance						
	Compliance Description		Data	Comp	liance Description	Data
	N/A	Ramp Length (in)	48.0	No	Ramp Slope (%)	10.4
	Yes	Ramp Width (in)	48.0	Yes	Ramp XSlope (%)	0.6
	N/A	Flare Type LT	N/A	N/A	Flare Type RT	N/A
	N/A	Flare Slope LT (%)	N/A	N/A	Flare Slope RT (%)	N/A
	N/A	Flare Traversable LT?	N/A	N/A	Flare Traversable RT?	N/A
	N/A	Landing Length (in)	N/A	N/A	DWS Provided?	N/A
	N/A	Landing Width (in)	N/A	N/A	DWS Contrast?	N/A
	N/A	Landing Slope (%)	N/A	N/A	DWS Length (in)	N/A
	N/A	Landing X Slope (%)	N/A	N/A	DWS Full Width?	N/A
	N/A	Landing Curb? (Y/N)	N/A	N/A	DWS Offset (in)	N/A
	N/A	Shared Landing?	N/A			
	N/A	Gutter Ponding?	N/A	N/A	Gutter Slope (%)	N/A
	N/A	Gutter Lip Ht (in)	N/A	N/A	Gutter X Slope (%)	N/A
	N/A	Painted X Walk1?	No	N/A	Painted X Walk2?	No
		X Walk 1 Direction	To W		X Walk 2 Direction	To S
	N/A	X Walk 1 Width (in)	N/A	N/A	X Walk 2 Width (in)	N/A
		X Walk 1 Slope (%)	1.4		X Walk 2 Slope (%)	0.1

X Walk 1 X Slope (%)	2.0		X Walk 2 X Slope (%)	1.4
	N/A	Ramp inside XWalk1?	N/A	N/A	Ramp inside XWalk2?	N/A
		Road Slope (%)	1.6	N/A	Clear Space?	N/A
		Road X Slope (%)	4.0	N/A	Clear Space to XWalk (in)	N/A
	N/A	Any Obstructions?	N/A	N/A	Storm Grate/Utility Hazard?	N/A
		Obstruction Type			Storm Grate/Utility Type	
			N/A			N/A
				Yes	Surface Condition? (G/P)	Good
College College	- W1	Market State of the Control of the C

Possible Solutions: **Remove & Replace Curb Ramp With Two New Directional Ramps or** Equivalent. Surveyor Notes: N/A PROW/ADA: Not Found, R304.2.2
