## Access Compliance Report Public Rights-of-Way (Curb Ramps)

Intersection ID: 25211Main Street:SMITH\_RDCross Street:SOUTHBRIDGE\_FOREST\_DRLocation:SEADA ID: ADAB08BA14C1Ramp Type:PerpInitial Pass/Fail:FailOverall Compliance:NoSeverity Score:13.75

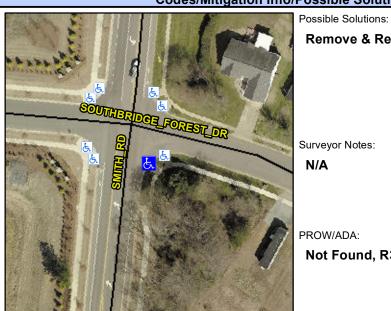
i	Fussible Solutions.	
į	Remove & Replace Entire Ramp.	N
		Y
4		N
1		N
No. of Lot		N
		N
1	Surveyor Notes:	N
	N/A	N
		N
1000		N
1		N
1	PROW/ADA:	N
Sept. In	Not Found, R304.2.2, R304.5.3	N
		N
		N
		N

Field Measurements/Component Compliance								
Comp	liance Description	Data	Comp	liance Description	Data			
N/A	Ramp Length (in)	119.0	No	Ramp Slope (%)	10.2			
Yes	Ramp Width (in)	85.0	No	Ramp XSlope (%)	2.6			
N/A	Flare Type LT	N/A	N/A	Flare Type RT	N/A			
N/A	Flare Slope LT (%)	N/A	N/A	Flare Slope RT (%)	N/A			
N/A	Flare Traversable LT?	N/A	N/A	Flare Traversable RT?	N/A			
N/A	Landing Length (in)	N/A	N/A	DWS Provided?	N/A			
N/A	Landing Width (in)	N/A	N/A	DWS Contrast?	N/A			
N/A	Landing Slope (%)	N/A	N/A	DWS Length (in)	N/A			
N/A	Landing X Slope (%)	N/A	N/A	DWS Full Width?	N/A			
N/A	Landing Curb? (Y/N)	N/A	N/A	DWS Offset (in)	N/A			
N/A	Shared Landing?	N/A						
N/A	Gutter Ponding?	N/A	N/A	Gutter Slope (%)	N/A			
N/A	Gutter Lip Ht (in)	N/A	N/A	Gutter X Slope (%)	N/A			
N/A	Painted X Walk1?	No	N/A	Painted X Walk2?	N/A			
	X Walk 1 Direction	To NW		X Walk 2 Direction	N/A			
N/A	X Walk 1 Width (in)	N/A	N/A	X Walk 2 Width (in)	N/A
