Access Compliance Report Public Rights-of-Way (Curb Ramps)

Intersection ID: 27495 Main Street: BALLANTYNE_COMMONS_PY Cross Street: NORTH_COMMUNITY_HOUSE_RD Location: SE

ADA ID: ADD1A4D05BA0 Ramp Type: Perp Initial Pass/Fail: Fail Overall Compliance: No Severity Score: 8.75

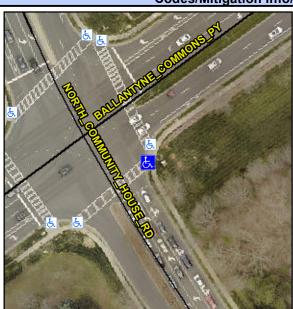
Field Measurements/Component Compliance							
Comp	liance Description	Data	Comp	liance Description	Data		
N/A	Ramp Length (in)	107.0	Yes	Ramp Slope (%)	6.0		
No	Ramp Width (in)	38.0	Yes	Ramp XSlope (%)	0.4		
N/A	Flare Type LT	N/A	N/A	Flare Type RT	N/A		
N/A	Flare Slope LT (%)	N/A	N/A	Flare Slope RT (%)	N/A		
N/A	Flare Traversable LT?	N/A	N/A	Flare Traversable RT?	N/A		
N/A	Landing Length (in)	N/A	N/A	DWS Provided?	N/A		
N/A	Landing Width (in)	N/A	N/A	DWS Contrast?	N/A		
N/A	Landing Slope (%)	N/A	N/A	DWS Length (in)	N/A		
N/A	Landing X Slope (%)	N/A	N/A	DWS Full Width?	N/A		
N/A	Landing Curb? (Y/N)	N/A	N/A	DWS Offset (in)	N/A		
N/A	Shared Landing?	N/A					
N/A	Gutter Ponding?	N/A	N/A	Gutter Slope (%)	N/A		
N/A	Gutter Lip Ht (in)	N/A	N/A	Gutter X Slope (%)	N/A		
N/A	Painted X Walk1?	Yes	N/A	Painted X Walk2?	N/A		
	X Walk 1 Direction	To SW		X Walk 2 Direction	N/A		
N/A	X Walk 1 Width (in)	124.0	N/A	X Walk 2 Width (in)	N/A

X Walk 1 Slope (%)	2.2		X Walk 2 Slope (%)	N/A		
	X Walk 1 X Slope (%)	2.9		X Walk 2 X Slope (%)	N/A		
N/A	Ramp inside XWalk1?	Yes	N/A	Ramp inside XWalk2?	N/A		
	Road Slope (%)	N/A	N/A	Clear Space?	N/A		
	Road X Slope (%)	N/A	N/A	Clear Space to XWalk (in)	N/A		
N/A	Any Obstructions?	N/A	N/A	Storm Grate/Utility Hazard?	N/A		
	Obstruction Type			Storm Grate/Utility Type			
		N/A			N/A		
			Yes	Surface Condition? (G/P)	Good

/Possible Solution	
Possible Solutions:	Com
Remove & Replace Entire Ramp.	N/A
·	No
	N/A
	N/A
	N/A
	N/A
Surveyor Notes:	N/A
N/A	N/A
	N/A
	N/A
	N/A
PROW/ADA:	N/A
Not Found, R304.5.1	N/A
	N/A
	N/A
	N/A
