## **Access Compliance Report Public Rights-of-Way** (Curb Ramps)

Intersection ID: 13177 Main Street: BETHEL RD **Cross Street: CARTIER WY** Location: W **ADA ID: AED80FDE56CA**

**Overall Compliance: No** Ramp Type: BlendTrans2 Initial Pass/Fail: Fail Severity Score: 33.75

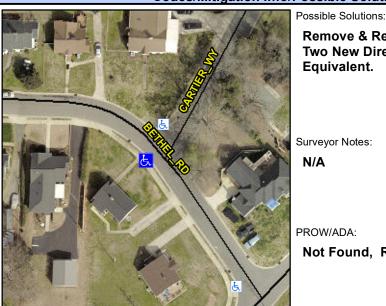
Not Found, R304.5.1, R304.5.3 Total Cost:

**BETHAL RD** Street 1 Name Stop Condition-Street 1 None N/A Street 2 Name Stop Condition-Street 2 N/A Remove & Replace Curb Ramp With Two New Directional Ramps or Equivalent.
