Access Compliance Report Public Rights-of-Way (Curb Ramps)

Cross Street: CASA LYNDA LN Intersection ID: 8785 Main Street: HOOD RD Location: NE Initial Pass/Fail: Fail **Overall Compliance: No** 25 ADA ID: AF65FC07DE4B Ramp Type: Combination2 **Severity Score:**

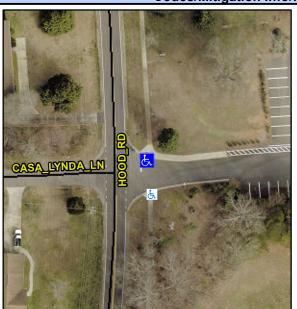
Possible Solutions: Compliance Description N/A Remove & Replace Entire Ramp. N/A N/A N/A N/A Yes Surveyor Notes: N/A N/A N/A N/A N/A N/A PROW/ADA: N/A Not Found, R304.5.1, R304.5.3 N/A N/A N/A N/A N/A
