Access Compliance Report Public Rights-of-Way (Curb Ramps)

Intersection ID: 44267 Main Street: BRITTNI_DAYLE_DR Cross Street: ISAAC_HUNTER_DR Location: NE

ADA ID: AF71EA44BA35 Ramp Type: BlendTrans1 Initial Pass/Fail: Fail Overall Compliance: No Severity Score: 21.25

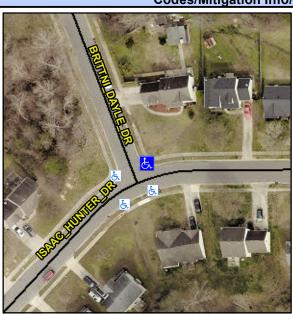
Field Measure	ements/C	ompo	nent Compliance		
Compliance Description		Data	Compliance Description		Data	
N/A	Ramp Length (in)	42.5	Yes	BlendTrans Slope (%)	2.8	
No	Ramp Width (in)	47.0	No	BlendTrans XSlope (%)	5.5	
N/A	Flare Type LT	N/A	N/A	Flare Type RT	N/A	
N/A	Flare Slope LT (%)	N/A	N/A	Flare Slope RT (%)	N/A	
N/A	Flare Traversable LT?	N/A	N/A	Flare Traversable RT?	N/A	
N/A	Landing Length (in)	N/A	N/A	DWS Provided?	N/A	
N/A	Landing Width (in)	N/A	N/A	DWS Contrast?	N/A	
N/A	Landing Slope (%)	N/A	N/A	DWS Length (in)	N/A	
N/A	Landing X Slope (%)	N/A	N/A	DWS Full Width?	N/A	
N/A	Landing Curb? (Y/N)	N/A	N/A	DWS Offset (in)	N/A	
N/A	Shared Landing?	N/A				
N/A	Gutter Ponding?	N/A	N/A	Gutter Slope (%)	N/A	
N/A	Gutter Lip Ht (in)	N/A	N/A	Gutter X Slope (%)	N/A	
N/A	Painted X Walk1?	No	N/A	Painted X Walk2?	No	
	X Walk 1 Direction	To W		X Walk 2 Direction	To S	
	X Walk 1 Width (in)	N/A		X Walk 2 Width (in)	N/A

X Walk 1 Slope (%)	0.4		X Walk 2 Slope (%)	4.7	
	X Walk 1 X Slope (%)	4.6		X Walk 2 X Slope (%)	1.3	
N/A	Ramp inside XWalk1?	N/A	N/A	Ramp inside XWalk2?	N/A	
	Road Slope (%)	6.4		Clear Space?	N/A	
	Road X Slope (%)	3.6	N/A	Clear Space to XWalk (in)	N/A	
N/A	Any Obstructions?	N/A	N/A	Storm Grate/Utility Hazard?	N/A	
	Obstruction Type			Storm Grate/Utility Type		
		N/A			N/A	
			Yes	Surface Condition? (G/P)	Good	
			No	Curb Slope (%)	7.0

Possible Solution							
Possible Solutions:							
Remove & Replace Curb Ramp With Two New Directional Ramps or Equivalent.							
Surveyor Notes:							
Surveyor Notes.							
N/A							
PROW/ADA:							
Not Found, R304.5.1, R304.5.3
