# Access Compliance Report

## Public Rights-of-Way

| Intersection ID: 5144 | Main Street: MASON_DR | Cross Street: TURNEY_RD | Location: | E |
| ADA ID: B03CCF970FA5 | Ramp Type: Perp | Initial Pass/Fail: Fail | Overall Compliance: No | Severity Score: 35 |

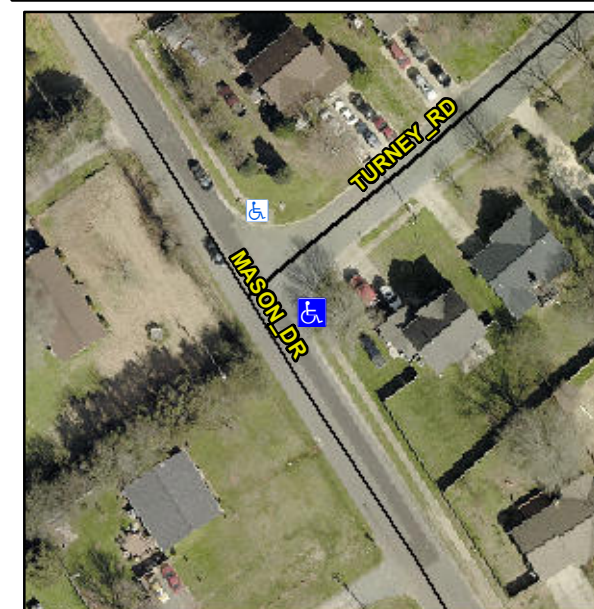
**R304.5.1, R304.2.2, R304.5.3**

| Compliance | Description | Data | Compliance | Description | Data |
|---|---|---|---|---|---|
| N/A | Ramp Length (in) | 48.0 | No | Ramp Slope (%) | 14.4 |
| No | Ramp Width (in) | 47.0 | No | Ramp XSlope (%) | 2.4 |

**Remove & Replace Entire Ramp.**
