Access Compliance Report

Public Rights-of-Way

(Curb Ramps)

Intersection ID: 44071	Main Street: NEWLANDS_CORNER_LN	Cross Street: SEDGEMOOR_LN	Location: SE
ADA ID: B05B589DDC13	Ramp Type: PerpDiag	Initial Pass/Fail: Fail	Overall Compliance: No
Severity Score: 18.75			
Codes/Mitigation Info/Possible Solution		Field Measurements/Component Compliance

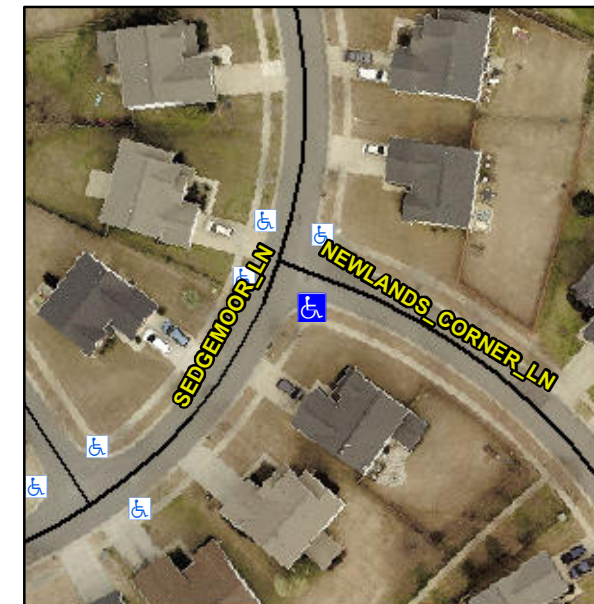
Compliance	Description	Data	Compliance	Description	Data
N/A	Ramp Length (in)	66.0	Yes	Ramp Slope (%)	5.9
No	Ramp Width (in)	35.0	No	Ramp XSlope (%)	2.3
N/A	Flare Type LT	N/A	N/A	Flare Type RT	N/A
N/A	Flare Slope LT (%)	N/A	N/A	Flare Slope RT (%)	N/A
N/A	Flare Traversable LT?	N/A	N/A	Flare Traversable RT?	N/A
N/A	Landing Length (in)	N/A	N/A	DWS Provided?	N/A
N/A	Landing Width (in)	N/A	N/A	DWS Contrast?	N/A
N/A	Landing Slope (%)	N/A	N/A	DWS Length (in)	N/A
N/A	Landing X Slope (%)	N/A	N/A	DWS Full Width?	N/A
N/A	Landing Curb? (Y/N)	N/A	N/A	DWS Offset (in)	N/A
N/A	Shared Landing?	N/A			
N/A	Gutter Ponding?	N/A	N/A	Gutter Slope (%)	N/A
N/A	Gutter Lip Ht (in)	N/A	N/A	Gutter X Slope (%)	N/A
N/A	Painted X Walk1?	No	N/A	Painted X Walk2?	No
	X Walk 1 Direction	To NE		X Walk 2 Direction	To NW
N/A	X Walk 1 Width (in)	N/A	N/A	X Walk 2 Width (in)	N/A
	X Walk 1 Slope (%)	0.8		X Walk 2 Slope (%)	5.9
	X Walk 1 X Slope (%)	4.1		X Walk 2 X Slope (%)	0.2

N/A	Ramp inside XWalk1?	N/A	N/A	Ramp inside XWalk2?	N/A
	Road Slope (%)	2.1	N/A	Clear Space?	N/A
	Road X Slope (%)	1.9	N/A	Clear Space to XWalk (in)	N/A
N/A	Any Obstructions?	N/A	N/A	Storm Grate/Utility Hazard?	N/A
	Obstruction Type			Storm Grate/Utility Type	
		N/A			N/A
		Yes		Surface Condition? (G/P)	Good

Remove & Replace Curb Ramp With Two New Directional Ramps or Equivalent.

R304.5.1, R304.5.3
