## Access Compliance Report Public Rights-of-Way (Curb Ramps)

Intersection ID: 28067Main Street:LANDEN\_DRCross Street:SOUTH\_BEND\_LNLocation:NWADA ID: B0621E883615Ramp Type:PerpDiagInitial Pass/Fail:FailOverall Compliance:NoSeverity Score:21.25

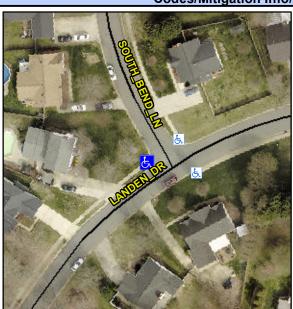
Not Found, R304.5.1, R304.2.2

Compliance Description D		Data	Compliance Description		Data
N/A	Ramp Length (in)	60.0	No	Ramp Slope (%)	9.0
No	Ramp Width (in)	46.0	Yes	Ramp XSlope (%)	0.1
N/A	Flare Type LT	N/A	N/A	Flare Type RT	N/A
N/A	Flare Slope LT (%)	N/A	N/A	Flare Slope RT (%)	N/A
N/A	Flare Traversable LT?	N/A	N/A	Flare Traversable RT?	N/A
N/A	Landing Length (in)	N/A	N/A	DWS Provided?	N/A
N/A	Landing Width (in)	N/A	N/A	DWS Contrast?	N/A
N/A	Landing Slope (%)	N/A	N/A	DWS Length (in)	N/A
N/A	Landing X Slope (%)	N/A	N/A	DWS Full Width?	N/A
N/A	Landing Curb? (Y/N)	N/A	N/A	DWS Offset (in)	N/A
N/A	Shared Landing?	N/A			
N/A	Gutter Ponding?	N/A	N/A	Gutter Slope (%)	N/A
N/A	Gutter Lip Ht (in)	N/A	N/A	Gutter X Slope (%)	N/A
N/A	Painted X Walk1?	No	N/A	Painted X Walk2?	No
	X Walk 1 Direction	To SE		X Walk 2 Direction	To NE
N/A	X Walk 1 Width (in)	N/A	N/A	X Walk 2 Width (in)	N/A
	X Walk 1 Slope (%)	4.1		X Walk 2 Slope (%)	3.3
	X Walk 1 X Slope (%)	0.8		X Walk 2 X Slope (%)	0.1

N/A	Ramp inside XWalk1?	N/A	N/A	Ramp inside XWalk2?	N/A
	Road Slope (%)	0.1	N/A	Clear Space?	N/A
	Road X Slope (%)	2.7	N/A	Clear Space to XWalk (in)	N/A
N/A	Any Obstructions?	N/A	N/A	Storm Grate/Utility Hazard?	N/A
	Obstruction Type		l	Storm Grate/Utility Type	
		N/A			N/A
			Yes	Surface Condition? (G/P)	Good

Remove & Replace Curb Ramp With Two New Directional Ramps or Equivalent.
