# Access Compliance Report

## Public Rights-of-Way

### (Curb Ramps)

Intersection ID: 51519	Main Street: E JOHN BELK RA	Cross Street: SOUTH BV	Location: SW
ADA ID: B0A54C5D5BA8	Ramp Type: Perp	Initial Pass/Fail: Fail	Overall Compliance: No
			Severity Score: 8.75

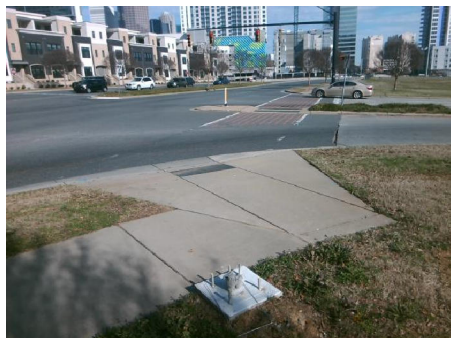
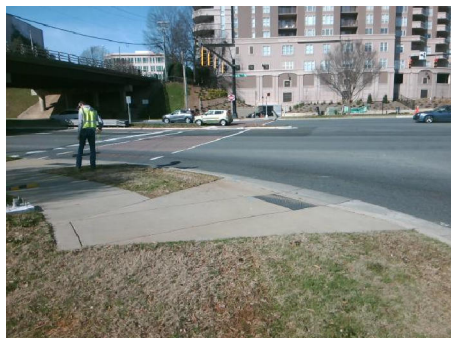
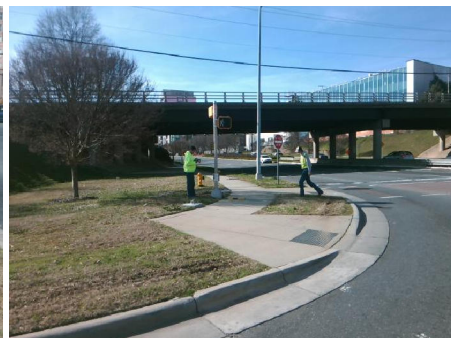
Compliance	Description	Data	Compliance	Description	Data
N/A	Ramp Length (in)	160.0	Yes	Ramp Slope (%)	5.7
No	Ramp Width (in)	47.0	Yes	Ramp XSlope (%)	0.9
N/A	Flare Type LT	N/A	N/A	Flare Type RT	N/A
N/A	Flare Slope LT (%)	N/A	N/A	Flare Slope RT (%)	N/A
N/A	Flare Traversable LT?	N/A	N/A	Flare Traversable RT?	N/A
N/A	Landing Length (in)	N/A	N/A	DWS Provided?	N/A
N/A	Landing Width (in)	N/A	N/A	DWS Contrast?	N/A
N/A	Landing Slope (%)	N/A	N/A	DWS Length (in)	N/A
N/A	Landing X Slope (%)	N/A	N/A	DWS Full Width?	N/A
N/A	Landing Curb? (Y/N)	N/A	N/A	DWS Offset (in)	N/A
N/A	Shared Landing?	N/A			
N/A	Gutter Ponding?	N/A	N/A	Gutter Slope (%)	N/A
N/A	Gutter Lip Ht (in)	N/A	N/A	Gutter X Slope (%)	N/A
N/A	Painted X Walk1?	Yes	N/A	Painted X Walk2?	N/A
	X Walk 1 Direction	To NE		X Walk 2 Direction	N/A
N/A	X Walk 1 Width (in)	133.0	N/A	X Walk 2 Width (in)	N/A
	X Walk 1 Slope (%)	4.2		X Walk 2 Slope (%)	N/A
	X Walk 1 X Slope (%)	5.9		X Walk 2 X Slope (%)	N/A

N/A	Ramp inside XWalk1?	Yes	N/A	Ramp inside XWalk2?	N/A
	Road Slope (%)	N/A	N/A	Clear Space?	N/A
	Road X Slope (%)	N/A	N/A	Clear Space to XWalk (in)	N/A
N/A	Any Obstructions?	N/A	N/A	Storm Grate/Utility Hazard?	N/A
	Obstruction Type			Storm Grate/Utility Type	
			N/A		N/A
			Yes	Surface Condition? (G/P)	Good

Possible Solutions:				
	Remove & Replace Entire Ramp.				
<p>Surveyor Notes:</p> <p>N/A</p> <p>PROW/ADA:</p> <p>R304.5.1</p>					
<p>Street 1 Name</p> <p>Stop Condition-Street 2</p> <p>Street 2 Name</p> <p>Stop Condition-Street 1</p>	E JOHN BELK RA				
	Signal				
	N/A				
	N/A				
<p>Total Cost:</p> <p>\$ 1850.00</p>
