Access Compliance Report Public Rights-of-Way (Curb Ramps)

Intersection ID: 2789 Main St	Main Street: MARSHBANK_LN			RIDGEFIELD_DR	Location:	SW		
ADA ID: B0CC78015E7B Ramp 1	E7B Ramp Type: Perp		Initial Pass/Fail: Fail Overall Compliance: No				o Severity Score:	58.75
Codes/Mitigation Info/Possible Solution		Field Measurements/Component Compliance						
Possible Solutions:			Compliance Description Dat			a Compliance Description Data		
12 12 Torrent Maria	Remove & Replace Entire Ramp		N/A	Ramp Length (in)	48.0	No	Ramp Slope (%)	13.1
			No	Ramp Width (in)	38.0	No	Ramp XSlope (%)	7.5
		1	N/A	Flare Type LT	N/A	N/A	Flare Type RT	N/A
			N/A	Flare Slope LT (%)	N/A	N/A	Flare Slope RT (%)	N/A
		1	N/A	Flare Traversable LT?	N/A	N/A	Flare Traversable RT?	N/A
			N/A	Landing Length (in)	N/A	N/A	DWS Provided?	N/A
THE PARTY IN COMPANY	Surveyor Notes:		N/A	Landing Width (in)	N/A	N/A	DWS Contrast?	N/A
The B	N/A		N/A	Landing Slope (%)	N/A	N/A	DWS Length (in)	N/A
		1	N/A	Landing X Slope (%)	N/A	N/A	DWS Full Width?	N/A

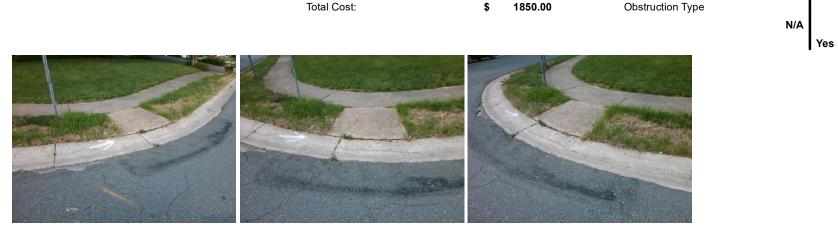
2 A Plantin P		1	N/A	Landing Curb? (Y/N)	N/A	N/A	DWS Offset (in)	N/A
AN A NO PATIENS	5×	1	N/A	Shared Landing?	N/A			
And the second states	PROW/ADA:	1	N/A	Gutter Ponding?	N/A	N/A	Gutter Slope (%)	N/A
	Not Found, R304.5.1, R304.2.2,		N/A	Gutter Lip Ht (in)	N/A	N/A	Gutter X Slope (%)	N/A
	R304.5.3	1	N/A	Painted X Walk1?	No	N/A	Painted X Walk2?	N/A
TOTAL CARACTER AND A SECOND				X Walk 1 Direction	To N		X Walk 2 Direction	N/A

- State and the second		1	N/A	X Walk 1 Width (in)	N/A	N/A	X Walk 2 Width (in)	N/A
Street 1 Name MARSHBANK LN	-			X Walk 1 Slope (%)	2.2		X Walk 2 Slope (%)	N/A
Stop Condition-Street 2 StopSign				X Walk 1 X Slope (%)	3.6		X Walk 2 X Slope (%)	N/A
Street 2 Name N/A			N/A	Ramp inside XWalk1?	N/A	N/A	Ramp inside XWalk2?	N/A
Stop Condition-Street 1 N/A				Road Slope (%)	N/A	N/A	Clear Space?	N/A
				Road X Slope (%)	N/A	N/A	Clear Space to XWalk (in)	N/A
			N/A	Any Obstructions?	N/A	N/A	Storm Grate/Utility Hazard?	N/A
	Total Cost: \$	850.00		Obstruction Type			Storm Grate/Utility Type	
					N/A			N/A
