Access Compliance Report

Public Rights-of-Way

(Curb Ramps)

| Intersection ID: 8589 | Main Street: BRADFORD_DR | Cross Street: WILLARD_ST | Location: S |

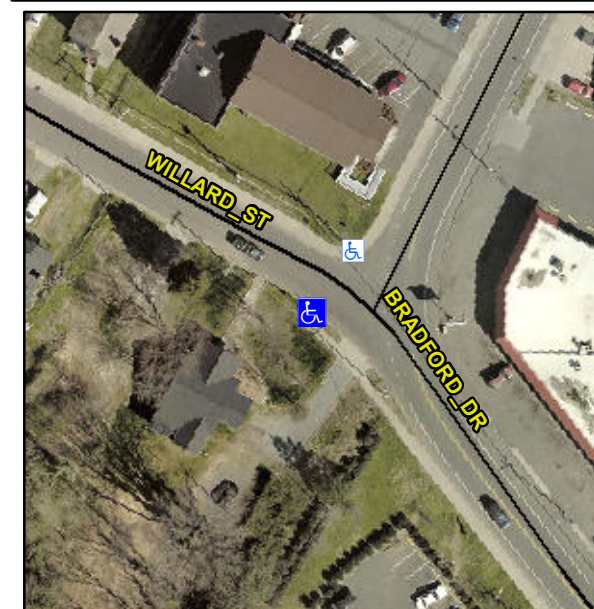
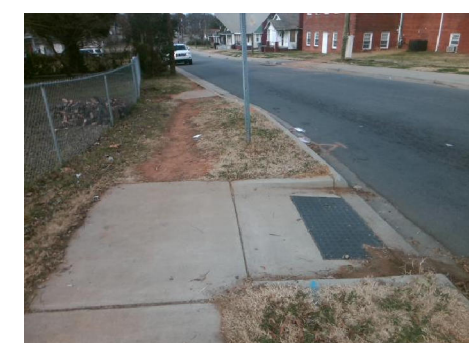
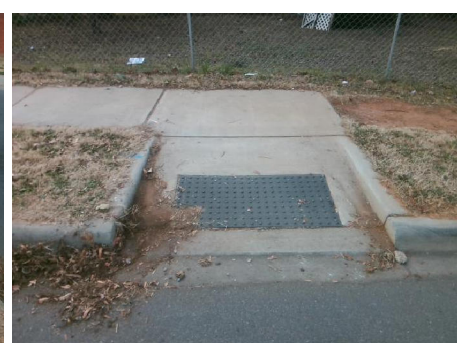
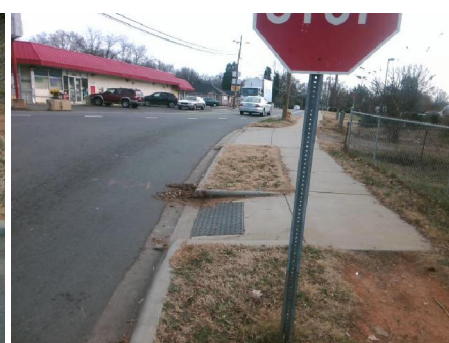
| ADA ID: B1062A7BB560 | Ramp Type: Perp | Initial Pass/Fail: Fail | Overall Compliance: No |
| Severity Score: 13.75 | | | |

Not Found, R304.2.2, R304.5.3

| Compliance | Description | Data | Compliance | Description | Data |
|---|---|---|---|---|---|
| N/A | Ramp Length (in) | 50.0 | No | Ramp Slope (%) | 11.4 |
| Yes | Ramp Width (in) | 71.5 | No | Ramp XSlope (%) | 2.6 |

Remove & Replace Entire Ramp.
