Access Compliance Report Public Rights-of-Way (Curb Ramps)

Intersection ID: 52440	Main Sti	Main Street: WOODWARD_AV			DOUBLE_OAKS_RD	Location: E				
ADA ID: B10FE1A40D26		Ramp Type: PerpDiag			Initial Pass/Fail: Fail Overall Complian					
Codes/Mitigation Info/Possible Solution				Field Measurements/Component Compliance						
		Possible Solutions:					Data Compliance Description			
		Remove & Replace Curb Ramp	With	N/A	Ramp Length (in)	27.0	No	Ramp Slope (%)	10.0	
		Two New Directional Ramps or		Yes	Ramp Width (in)	68.5	Yes	Ramp XSlope (%)	1.1	
		Equivalent.		N/A	Flare Type LT	N/A	N/A	Flare Type RT	N/A	
		1		N/A	Flare Slope LT (%)	N/A	N/A	Flare Slope RT (%)	N/A	
				N/A	Flare Traversable LT?	N/A	N/A	Flare Traversable RT?	N/A	
and a second		1		N/A	Landing Length (in)	N/A	N/A	DWS Provided?	N/A	
		Surveyor Notes:		N/A	Landing Width (in)	N/A	N/A	DWS Contrast?	N/A	
the second secon		N/A		N/A	Landing Slope (%)	N/A	N/A	DWS Length (in)	N/A	
L CON				N/A	Landing X Slope (%)	N/A	N/A	DWS Full Width?	N/A

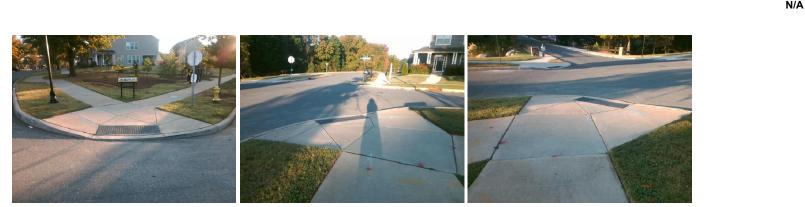
SAL AND			N/A	Landing Curb? (Y/N)	N/A	N/A	DWS Offset (in)	N/A	
· / · ·				N/A	Shared Landing?	N/A				
part 1	The second	PROW/ADA:		N/A	Gutter Ponding?	N/A	N/A	Gutter Slope (%)	N/A	
and the second	Martin Contraction	R304.2.2		N/A	Gutter Lip Ht (in)	N/A	N/A	Gutter X Slope (%)	N/A	
A CONTRACT OF THE REAL	A A	1004.2.2		N/A	Painted X Walk1?	No	N/A	Painted X Walk2?	No

L. M.				X Walk 1 Direction	To NW		X Walk 2 Direction	To SW	
	We share we			N/A	X Walk 1 Width (in)	N/A	N/A	X Walk 2 Width (in)	N/A	
Street 1 Name	DOUBLE OAKS RD	-			X Walk 1 Slope (%)	6.5		X Walk 2 Slope (%)	4.9	
Stop Condition-Street 2	None				X Walk 1 X Slope (%)	4.5		X Walk 2 X Slope (%)	8.7	
Street 2 Name	WOODWARD AV			N/A	Ramp inside XWalk1?	N/A	N/A	Ramp inside XWalk2?	N/A	
Stop Condition-Street 1	StopSign				Road Slope (%)	4.8		Clear Space?	N/A	
	. • •				Road X Slope (%)		N/A	Clear Space to XWalk (in)	N/A	
				N/A	Any Obstructions?	N/A		Storm Grate/Utility Hazard?	N/A	
		Total Cost: \$	3200.00		Obstruction Type			Storm Grate/Utility Type		
						N/A		5 51	N/A

Yes Surface Condition? (G/P) Good
