Access Compliance Report

Public Rights-of-Way

(Curb Ramps)

Intersection ID: 11166	Main Street: EASTWOOD_DR	Cross Street: MAYWOOD_DR	Location: E
ADA ID: B1150A6819BA	Ramp Type: Perp	Initial Pass/Fail: Fail	Overall Compliance: No
Severity Score: 13.75			
Codes/Mitigation Info/Possible Solution		Field Measurements/Component Compliance

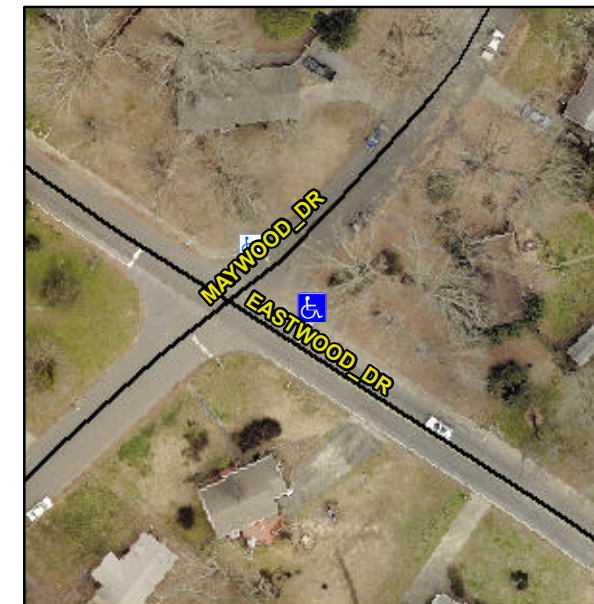
Not Found, R304.2.2, R304.5.3

Compliance	Description	Data	Compliance	Description	Data
N/A	Ramp Length (in)	46.5	No	Ramp Slope (%)	10.9
Yes	Ramp Width (in)	48.0	No	Ramp XSlope (%)	2.3
N/A	Flare Type LT	N/A	N/A	Flare Type RT	N/A
N/A	Flare Slope LT (%)	N/A	N/A	Flare Slope RT (%)	N/A
N/A	Flare Traversable LT?	N/A	N/A	Flare Traversable RT?	N/A
N/A	Landing Length (in)	N/A	N/A	DWS Provided?	N/A
N/A	Landing Width (in)	N/A	N/A	DWS Contrast?	N/A
N/A	Landing Slope (%)	N/A	N/A	DWS Length (in)	N/A
N/A	Landing X Slope (%)	N/A	N/A	DWS Full Width?	N/A
N/A	Landing Curb? (Y/N)	N/A	N/A	DWS Offset (in)	N/A
N/A	Shared Landing?	N/A			
N/A	Gutter Ponding?	N/A	N/A	Gutter Slope (%)	N/A
N/A	Gutter Lip Ht (in)	N/A	N/A	Gutter X Slope (%)	N/A
N/A	Painted X Walk1?	No	N/A	Painted X Walk2?	N/A
	X Walk 1 Direction	To NW		X Walk 2 Direction	N/A
N/A	X Walk 1 Width (in)	N/A	N/A	X Walk 2 Width (in)	N/A
	X Walk 1 Slope (%)	0.1		X Walk 2 Slope (%)	N/A
	X Walk 1 X Slope (%)	3.8		X Walk 2 X Slope (%)	N/A

Remove & Replace Entire Ramp.
