Access Compliance Report

Public Rights-of-Way

(Curb Ramps)

| Intersection ID: 3568 | Main Street: CLAIBORNE_WOODS_RD | Cross Street: COPENHAGEN_LN | Location: W |

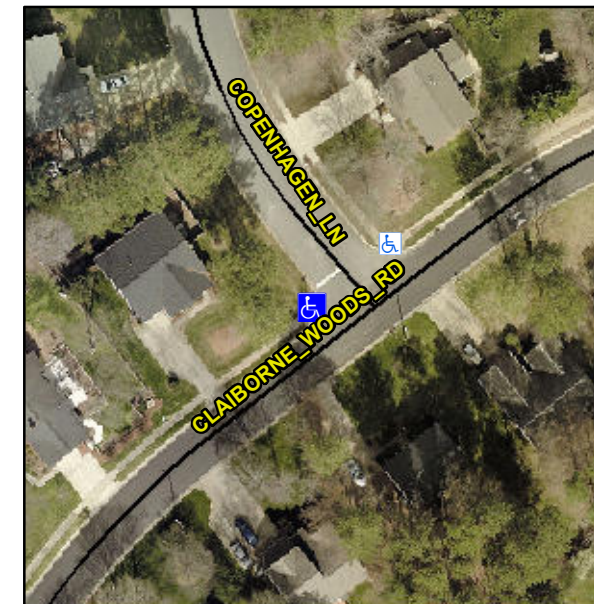
| ADA ID: B11ACD44EA61 | Ramp Type: Perp | Initial Pass/Fail: Fail | Overall Compliance: No |
| Severity Score: 13.75 | | | |

Not Found, R304.2.2, R304.5.3

| Compliance | Description | Data | Compliance | Description | Data |
|---|---|---|---|---|---|
| N/A | Ramp Length (in) | 33.0 | No | Ramp Slope (%) | 8.4 |
| Yes | Ramp Width (in) | 48.0 | No | Ramp XSlope (%) | 2.4 |

Remove & Replace Entire Ramp.
