# Access Compliance Report

## Public Rights-of-Way

| Intersection ID: 29998 | Main Street: WINDING_RIVER_DR | Cross Street: YEARWOOD_LN | Location: SW |
| ADA ID: B13A7110EFD5 | Ramp Type: PerpDiag | Initial Pass/Fail: Fail | Overall Compliance: No |

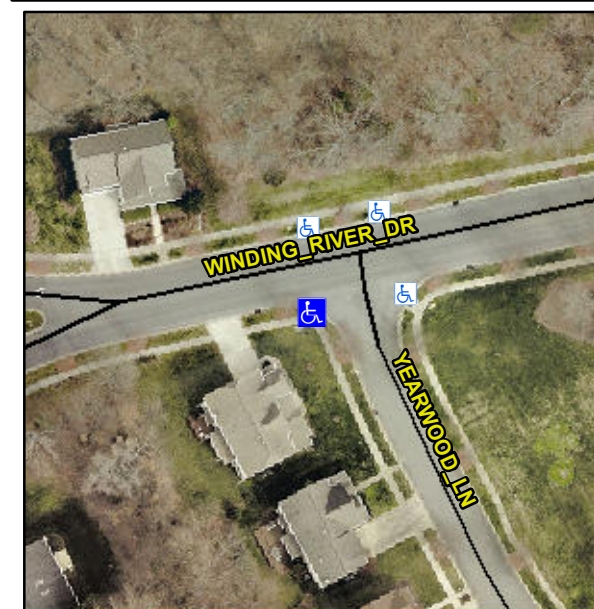
| Severity Score: 8.75 | | | |

**Not Found, R304.5.1**

| Compliance | Description | Data | Compliance | Description | Data |
|---|---|---|---|---|---|
| No | Ramp Width (in) | 43.0 | Yes | Ramp XSlope (%) | 1.0 |

**Remove & Replace Curb Ramp With Two New Directional Ramps or Equivalent.**

Total Cost: \$ 3200.00
