Access Compliance Report

Public Rights-of-Way (Curb Ramps)

Intersection ID: 4068	Main Street: FOGGY_BANK_LN	Cross Street: MT_ISLE_HARBOR_DR	Location: SW
ADA ID: B13A9847AF23	Ramp Type: Perp	Initial Pass/Fail: Fail	Overall Compliance: No
			Severity Score: 18.75

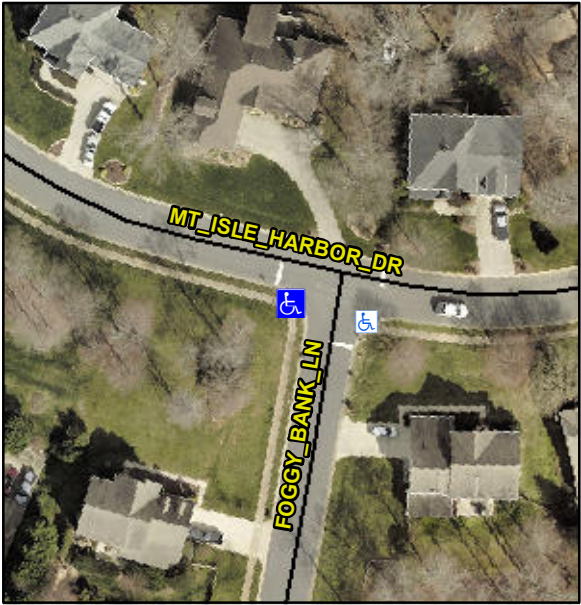
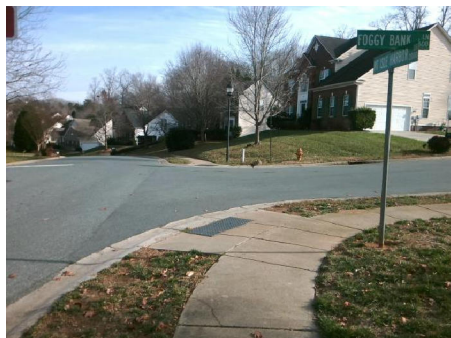
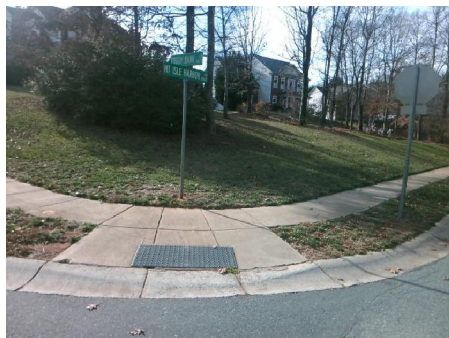
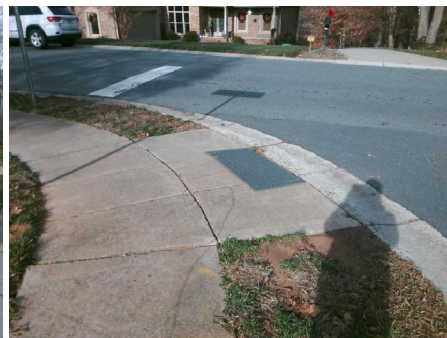
Compliance	Description	Data	Compliance	Description	Data
N/A	Ramp Length (in)	48.5	Yes	Ramp Slope (%)	8.2
No	Ramp Width (in)	32.0	No	Ramp XSlope (%)	2.4
N/A	Flare Type LT	N/A	N/A	Flare Type RT	N/A
N/A	Flare Slope LT (%)	N/A	N/A	Flare Slope RT (%)	N/A
N/A	Flare Traversable LT?	N/A	N/A	Flare Traversable RT?	N/A
N/A	Landing Length (in)	N/A	N/A	DWS Provided?	N/A
N/A	Landing Width (in)	N/A	N/A	DWS Contrast?	N/A
N/A	Landing Slope (%)	N/A	N/A	DWS Length (in)	N/A
N/A	Landing X Slope (%)	N/A	N/A	DWS Full Width?	N/A
N/A	Landing Curb? (Y/N)	N/A	N/A	DWS Offset (in)	N/A
N/A	Shared Landing?	N/A			
N/A	Gutter Ponding?	N/A	N/A	Gutter Slope (%)	N/A
N/A	Gutter Lip Ht (in)	N/A	N/A	Gutter X Slope (%)	N/A
N/A	Painted X Walk1?	No	N/A	Painted X Walk2?	N/A
	X Walk 1 Direction	To E		X Walk 2 Direction	N/A
N/A	X Walk 1 Width (in)	N/A	N/A	X Walk 2 Width (in)	N/A
	X Walk 1 Slope (%)	1.4		X Walk 2 Slope (%)	N/A
	X Walk 1 X Slope (%)	0.2		X Walk 2 X Slope (%)	N/A

N/A	Ramp inside XWalk1?	N/A	N/A	Ramp inside XWalk2?	N/A
	Road Slope (%)	N/A	N/A	Clear Space?	N/A
	Road X Slope (%)	N/A	N/A	Clear Space to XWalk (in)	N/A
N/A	Any Obstructions?	N/A	N/A	Storm Grate/Utility Hazard?	N/A
	Obstruction Type			Storm Grate/Utility Type	
		N/A			N/A
			Yes	Surface Condition? (G/P)	Good

Possible Solutions:				
	Remove & Replace Entire Ramp.				
	Surveyor Notes:				
	N/A				
	PROW/ADA:				
	Not Found, R304.5.1, R304.5.3				
Street 1 Name	FOGGY BANK LN				
Stop Condition-Street 2	StopSign				
Street 2 Name	N/A				
Stop Condition-Street 1	N/A				
Total Cost:		\$	1850.00
