# Access Compliance Report

## Public Rights-of-Way

### (Curb Ramps)

| Intersection ID: 30574 | Main Street: FLOWING_BROOK_CT | Cross Street: HAMILTON_GREEN_DR | Location: NE |

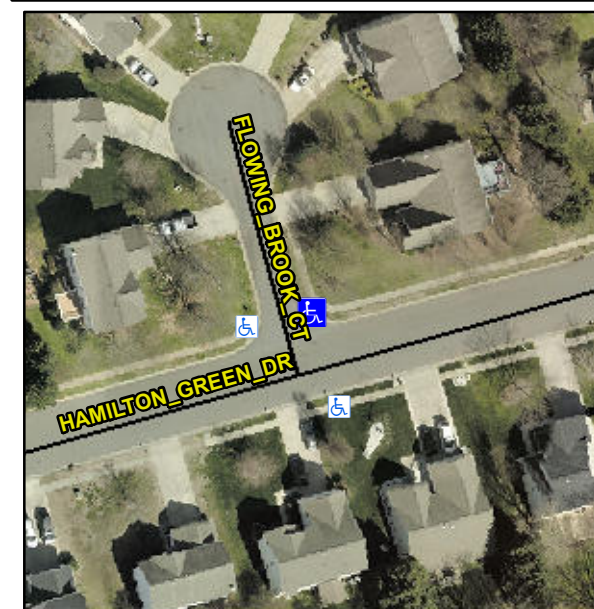
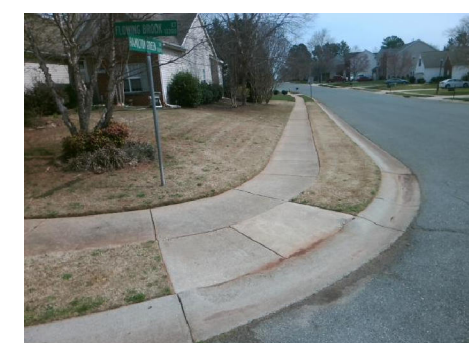
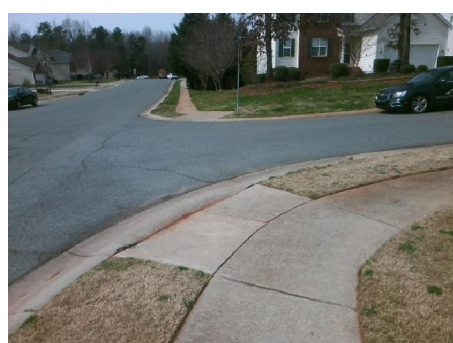
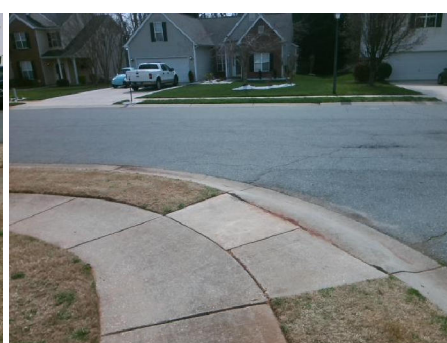
| ADA ID: B18BD0CE0980 | Ramp Type: PerpDiag | Initial Pass/Fail: Fail | Overall Compliance: No |
| Severity Score: 13.75 | | | |

**R304.2.2, R304.5.3**

| Compliance | Description | Data | Compliance | Description | Data |
|---|---|---|---|---|---|
| N/A | Ramp Length (in) | 43.0 | No | Ramp Slope (%) | 8.5 |
| Yes | Ramp Width (in) | 48.0 | No | Ramp XSlope (%) | 2.3 |

**Remove & Replace Curb Ramp With Two New Directional Ramps or Equivalent.**

Total Cost: \$ 3200.00
