# Access Compliance Report

## Public Rights-of-Way

### (Curb Ramps)

| Intersection ID: 23309 | Main Street: BRIDGEWOOD_LN | Cross Street: CARMEL_RD | Location: S |

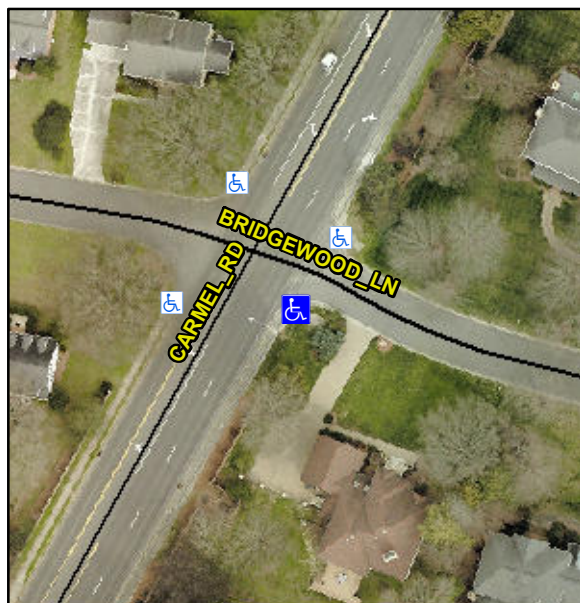
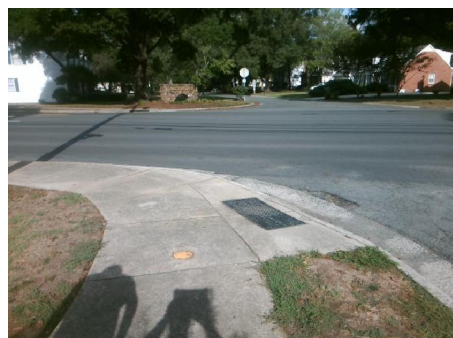
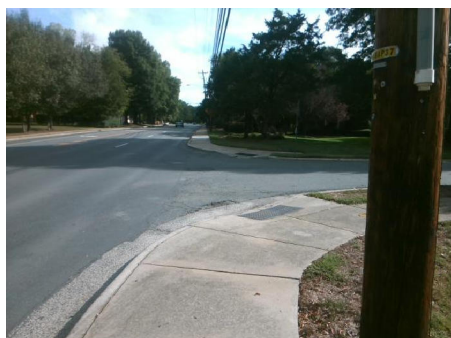
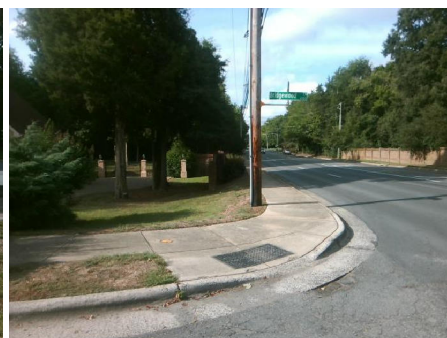
**Not Found, R304.2.1, R304.2.2-Perp, R304.3.2-Para, R304.5.3, R304.2.3, R305.1.4, R305.2, R302.7.2**

| Compliance | Description | Data | Compliance | Description | Data |
|---|---|---|---|---|---|
| No | Landing Length (in) | N/A | Yes | DWS Provided? | Yes |
| No | Landing X Slope (%) | N/A | No | DWS Full Width? | No |
| No | Gutter Lip Ht (in) | 1.5 | Yes | Gutter X Slope (%) | 1.1 |

**Remove & Replace Curb Ramp With Two New Directional Ramps or Equivalent.**
