Access Compliance Report Public Rights-of-Way (Curb Ramps)

Intersection ID: 6370Main Street: LAKE_RDCross Street: MILHAVEN_LNLocation:SEADA ID: B191CD58C921Ramp Type: PerpInitial Pass/Fail: FailOverall Compliance: NoSeverity Score:22.5

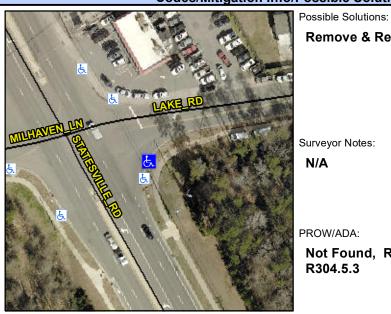
Surveyor Notes:		
N/A		
PROW/ADA:		
Not Found, R304.5.3	R304.5.1, R304.2.2,

Comp	liance Description	Data	Comp	liance	Description	Data
N/A	Ramp Length (in)	105.0	No	Ramp	Slope (%)	10.2
No	Ramp Width (in)	47.5	No	Ramp	XSlope (%)	2.8
N/A	Flare Type LT	N/A	N/A	Flare	Type RT	N/A
N/A	Flare Slope LT (%)	N/A	N/A	Flare	Slope RT (%)	N/A
N/A	Flare Traversable LT?	N/A	N/A	Flare	Traversable RT?	N/A
N/A	Landing Length (in)	N/A	N/A	DWS	Provided?	N/A
N/A	Landing Width (in)	N/A	N/A	DWS	Contrast?	N/A
N/A	Landing Slope (%)	N/A	N/A	DWS	Length (in)	N/A
N/A	Landing X Slope (%)	N/A	N/A	DWS	Full Width?	N/A
N/A	Landing Curb? (Y/N)	N/A	N/A	DWS	Offset (in)	N/A
N/A	Shared Landing?	N/A				
N/A	Gutter Ponding?	N/A	N/A	Gutte	er Slope (%)	N/A
N/A	Gutter Lip Ht (in)	N/A	N/A	Gutte	r X Slope (%)	N/A
N/A	Painted X Walk1?	No	N/A	Paint	ed X Walk2?	N/A
	X Walk 1 Direction	To N		X Wa	lk 2 Direction	N/A
N/A	X Walk 1 Width (in)	N/A	N/A	X Wa	lk 2 Width (in)	N/A
	X Walk 1 Slope (%)	0.4		X Wa	lk 2 Slope (%)	N/A
	X Walk 1 X Slope (%)	2.4		X Wa	lk 2 X Slope (%)	N/A

Remove & Replace Entire Ramp.
