Access Compliance Report Public Rights-of-Way (Curb Ramps)

Intersection ID: 14066 Main Street: MARKLAND DR Cross Street: MAYFAIR_AV Location: NE **ADA ID: B1927C5F33DA** Ramp Type: ParaDiag Initial Pass/Fail: Fail **Overall Compliance: No** Severity Score: 13.75

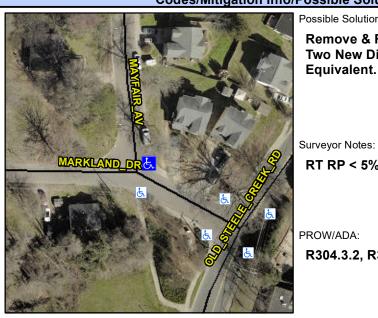
R304.3.2, R304.5.3

Compliance Description Data Compliance Description Data					
N/A	Ramp Length LT (in)	65.0	N/A	Ramp Length RT (in)	60.5
Yes	Ramp Width LT (in)	59.0	Yes	Ramp Width RT (in)	59.0
No	Ramp Slope LT (%)	11.5	Yes	Ramp Slope RT (%)	0.2
No	Ramp XSlope LT (%)	2.6	No	Ramp XSlope RT (%)	3.0
N/A	Landing Length (in)	N/A	N/A	DWS Provided?	N/A
N/A	Landing Width (in)	N/A	N/A	DWS Contrast?	N/A
N/A	Landing Slope (%)	N/A	N/A	DWS Length (in)	N/A
N/A	Landing X Slope (%)	N/A	N/A	DWS Full Width?	N/A
N/A	Landing Curb? (Y/N)	N/A	N/A	DWS Offset (in)	N/A
N/A N/A	Shared Landing?	N/A N/A	N/A	DWS Ollset (III)	N/A
N/A N/A	_	N/A	N/A	Gutter Slope (%)	N/A
N/A N/A	Gutter Ponding?	N/A N/A		1 ()	
	Gutter Lip Ht (in)		N/A	Gutter X Slope (%)	N/A
N/A	Painted X Walk1?	No	N/A	Painted X Walk2?	No
	X Walk 1 Direction	To W		X Walk 2 Direction	To S
N/A	X Walk 1 Width (in)	N/A	N/A	X Walk 2 Width (in)	N/A
	X Walk 1 Slope (%)	0.8		X Walk 2 Slope (%)	3.7
	X Walk 1 X Slope (%)	4.7		X Walk 2 X Slope (%)	3.1

N/A	Ramp inside XWalk1?	N/A	N/A	Ramp inside XWalk2?	N/A
	Road Slope (%)	4.8	N/A	Clear Space?	N/A
	Road X Slope (%)	3.5	N/A	Clear Space to XWalk (in)	N/A
N/A	Any Obstructions?	N/A	N/A	Storm Grate/Utility Hazard?	N/A
	Obstruction Type			Storm Grate/Utility Type	
		N/A			N/A
			Yes	Surface Condition? (G/P)	Good
			N/A	Curb Slope (%)	25.4

Possible Solutions: Remove & Replace Curb Ramp With Two New Directional Ramps or Equivalent.
