# Access Compliance Report

## Public Rights-of-Way

### (Curb Ramps)

Intersection ID: 42982	Main Street: LADORA_DR	Cross Street: LAVENDER_CR	Location: NE
ADA ID: B1929C0FB60B	Ramp Type: PerpDiag	Initial Pass/Fail: Fail	Overall Compliance: No
Severity Score: 10			
Codes/Mitigation Info/Possible Solution		Field Measurements/Component Compliance

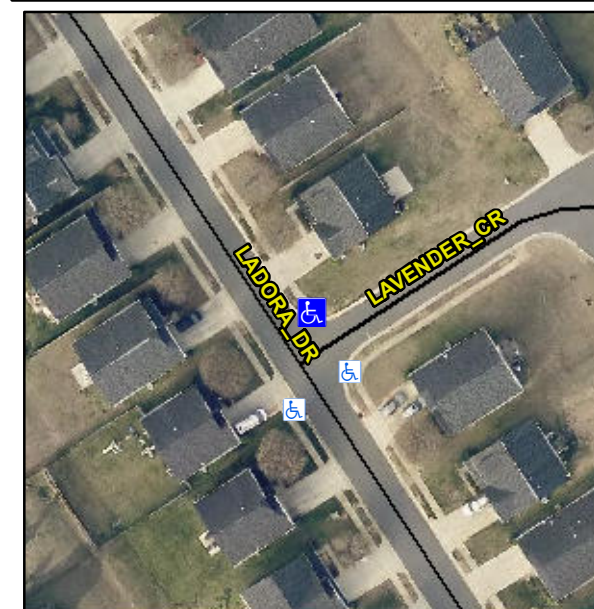
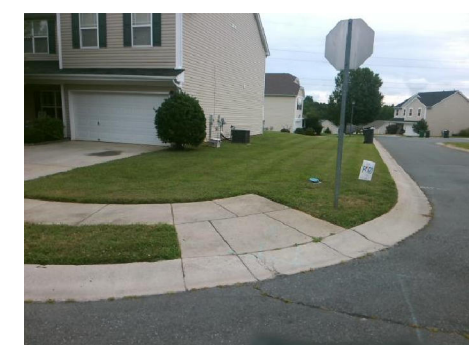
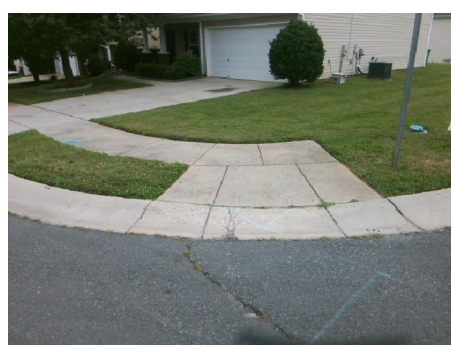
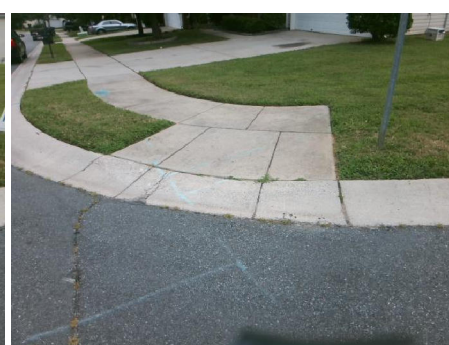
**Not Found, R304.5.1, R304.5.3**

Compliance	Description	Data	Compliance	Description	Data
N/A	Ramp Length (in)	51.0	Yes	Ramp Slope (%)	5.3
No	Ramp Width (in)	38.0	No	Ramp XSlope (%)	2.6
N/A	Flare Type LT	N/A	N/A	Flare Type RT	N/A
N/A	Flare Slope LT (%)	N/A	N/A	Flare Slope RT (%)	N/A
N/A	Flare Traversable LT?	N/A	N/A	Flare Traversable RT?	N/A
N/A	Landing Length (in)	N/A	N/A	DWS Provided?	N/A
N/A	Landing Width (in)	N/A	N/A	DWS Contrast?	N/A
N/A	Landing Slope (%)	N/A	N/A	DWS Length (in)	N/A
N/A	Landing X Slope (%)	N/A	N/A	DWS Full Width?	N/A
N/A	Landing Curb? (Y/N)	N/A	N/A	DWS Offset (in)	N/A
N/A	Shared Landing?	N/A			
N/A	Gutter Ponding?	N/A	N/A	Gutter Slope (%)	N/A
N/A	Gutter Lip Ht (in)	N/A	N/A	Gutter X Slope (%)	N/A
N/A	Painted X Walk1?	No	N/A	Painted X Walk2?	No
	X Walk 1 Direction	To SW		X Walk 2 Direction	To SE
N/A	X Walk 1 Width (in)	N/A	N/A	X Walk 2 Width (in)	N/A
	X Walk 1 Slope (%)	0.7		X Walk 2 Slope (%)	4.5
	X Walk 1 X Slope (%)	2.9		X Walk 2 X Slope (%)	3.6

N/A	Ramp inside XWalk1?	N/A	N/A	Ramp inside XWalk2?	N/A
	Road Slope (%)	2.4	N/A	Clear Space?	N/A
	Road X Slope (%)	4.0	N/A	Clear Space to XWalk (in)	N/A
N/A	Any Obstructions?	N/A	N/A	Storm Grate/Utility Hazard?	N/A
	Obstruction Type			Storm Grate/Utility Type	
		N/A			N/A
		Yes		Surface Condition? (G/P)	Good

**Remove & Replace Curb Ramp With Two New Directional Ramps or Equivalent.**
