Access Compliance Report

Public Rights-of-Way

(Curb Ramps)

Intersection ID: 53960	Main Street: DENBUR_DR	Cross Street: MAGNOLIA_LILY_AV	Location: NW
ADA ID: B1AC9851EF79	Ramp Type: Perp	Initial Pass/Fail: Fail	Overall Compliance: No
		Severity Score: 8.75

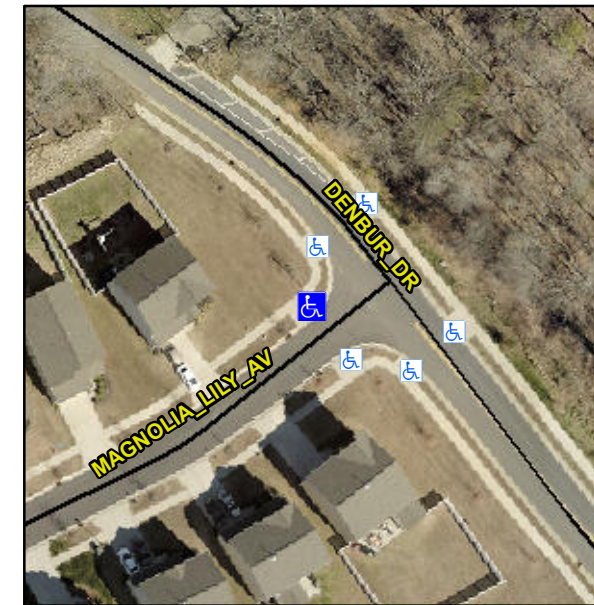
Not Found, R304.5.1

Compliance	Description	Data	Compliance	Description	Data
N/A	Ramp Length (in)	97.5	Yes	Ramp Slope (%)	6.8
No	Ramp Width (in)	46.5	Yes	Ramp XSlope (%)	1.4
N/A	Flare Type LT	N/A	N/A	Flare Type RT	N/A
N/A	Flare Slope LT (%)	N/A	N/A	Flare Slope RT (%)	N/A
N/A	Flare Traversable LT?	N/A	N/A	Flare Traversable RT?	N/A
N/A	Landing Length (in)	N/A	N/A	DWS Provided?	N/A
N/A	Landing Width (in)	N/A	N/A	DWS Contrast?	N/A
N/A	Landing Slope (%)	N/A	N/A	DWS Length (in)	N/A
N/A	Landing X Slope (%)	N/A	N/A	DWS Full Width?	N/A
N/A	Landing Curb? (Y/N)	N/A	N/A	DWS Offset (in)	N/A
N/A	Shared Landing?	N/A			
N/A	Gutter Ponding?	N/A	N/A	Gutter Slope (%)	N/A
N/A	Gutter Lip Ht (in)	N/A	N/A	Gutter X Slope (%)	N/A
N/A	Painted X Walk1?	No	N/A	Painted X Walk2?	N/A
	X Walk 1 Direction	To S		X Walk 2 Direction	N/A
N/A	X Walk 1 Width (in)	N/A	N/A	X Walk 2 Width (in)	N/A
	X Walk 1 Slope (%)	1.3		X Walk 2 Slope (%)	N/A
	X Walk 1 X Slope (%)	3.1		X Walk 2 X Slope (%)	N/A

Remove & Replace Entire Ramp.
