# Access Compliance Report

## Public Rights-of-Way

### (Curb Ramps)

Intersection ID: 8534	Main Street: ATANDO_AV	Cross Street: LASALLE_ST	Location: S
ADA ID: B20FDDDB56C29	Ramp Type: BlendTrans2	Initial Pass/Fail: Fail	Overall Compliance: No
Severity Score: 23.75			
Codes/Mitigation Info/Possible Solution		Field Measurements/Component Compliance

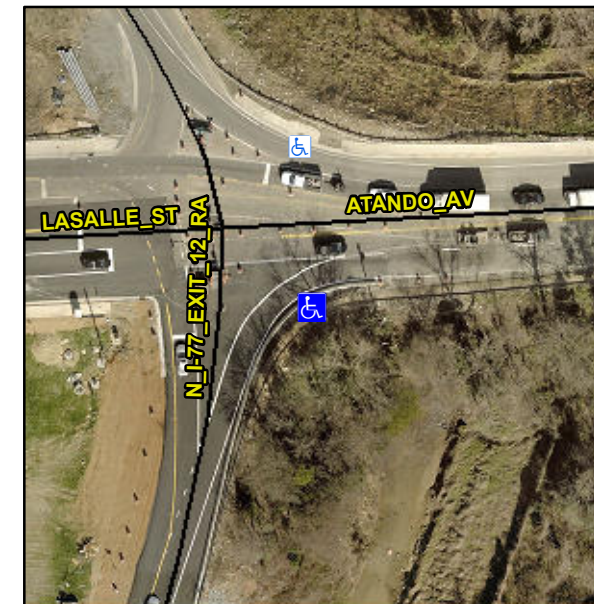
**DAMAGED DWS**

PROW/ADA:

**R304.5.1, R302.7**

Compliance	Description	Data	Compliance	Description	Data
N/A	Ramp Length (in)	72.0	Yes	BlendTrans Slope (%)	0.2
No	Ramp Width (in)	46.0	Yes	BlendTrans XSlope (%)	0.6
N/A	Flare Type LT	N/A	N/A	Flare Type RT	N/A
N/A	Flare Slope LT (%)	N/A	N/A	Flare Slope RT (%)	N/A
N/A	Flare Traversable LT?	N/A	N/A	Flare Traversable RT?	N/A
N/A	Landing Length (in)	N/A	N/A	DWS Provided?	N/A
N/A	Landing Width (in)	N/A	N/A	DWS Contrast?	N/A
N/A	Landing Slope (%)	N/A	N/A	DWS Length (in)	N/A
N/A	Landing X Slope (%)	N/A	N/A	DWS Full Width?	N/A
N/A	Landing Curb? (Y/N)	N/A	N/A	DWS Offset (in)	N/A
N/A	Shared Landing?	N/A			
N/A	Gutter Ponding?	N/A	N/A	Gutter Slope (%)	N/A
N/A	Gutter Lip Ht (in)	N/A	N/A	Gutter X Slope (%)	N/A
N/A	Painted X Walk1?	No	N/A	Painted X Walk2?	No
	X Walk 1 Direction	To N		X Walk 2 Direction	To W
	X Walk 1 Width (in)	N/A		X Walk 2 Width (in)	N/A
	X Walk 1 Slope (%)	7.0		X Walk 2 Slope (%)	6.2
	X Walk 1 X Slope (%)	4.6		X Walk 2 X Slope (%)	3.8

N/A	Ramp inside XWalk1?	N/A	N/A	Ramp inside XWalk2?	N/A
	Road Slope (%)	1.5		Clear Space?	N/A
	Road X Slope (%)	1.6	N/A	Clear Space to XWalk (in)	N/A
N/A	Any Obstructions?	N/A	N/A	Storm Grate/Utility Hazard?	N/A
	Obstruction Type			Storm Grate/Utility Type	
		N/A			N/A
		No		Surface Condition? (G/P)	Poor
		N/A		Curb Slope (%)	3.6

**Remove & Replace Curb Ramp With Two New Directional Ramps or Equivalent.**
