Access Compliance Report Public Rights-of-Way (Curb Ramps)

Intersection ID: 25924 Main Street: BAYBROOK_LN Cross Street: WOODLEIGH_OAKS_DR Location: SE

ADA ID: B299A6CFB052 Ramp Type: PerpDiag Initial Pass/Fail: Fail Overall Compliance: No Severity Score: 21.25

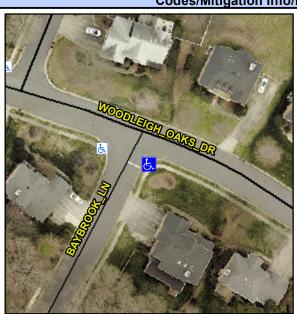
Not Found, R304.5.1, R304.5.3

Field Measurements/Component Compliance							
	Comp	Compliance Description		Compliance		Description	Data
	N/A	Ramp Length (in)	94.0	Yes	Ramp	Slope (%)	6.7
	No	Ramp Width (in)	43.5	No	Ramp	XSlope (%)	5.2
	N/A	Flare Type LT	N/A	N/A	Flare	Type RT	N/A
	N/A	Flare Slope LT (%)	N/A	N/A	Flare	Slope RT (%)	N/A
	N/A	Flare Traversable LT?	N/A	N/A	Flare	Traversable RT?	N/A
	N/A	Landing Length (in)	N/A	N/A	DWS	Provided?	N/A
	N/A	Landing Width (in)	N/A	N/A	DWS	Contrast?	N/A
	N/A	Landing Slope (%)	N/A	N/A	DWS	Length (in)	N/A
	N/A	Landing X Slope (%)	N/A	N/A	DWS	Full Width?	N/A
	N/A	Landing Curb? (Y/N)	N/A	N/A	DWS	Offset (in)	N/A
	N/A	Shared Landing?	N/A				
	N/A	Gutter Ponding?	N/A	N/A	Gutte	r Slope (%)	N/A
	N/A	Gutter Lip Ht (in)	N/A	N/A	Gutte	r X Slope (%)	N/A
	N/A	Painted X Walk1?	No	N/A	Paint	ed X Walk2?	No
		X Walk 1 Direction	To NE		X Wa	lk 2 Direction	To NW
	N/A	X Walk 1 Width (in)	N/A	N/A	X Wa	lk 2 Width (in)	N/A

X Walk 1 Slope (%)	4.4		X Wa	lk 2 Slope (%)	0.8
		X Walk 1 X Slope (%)	0.7		X Wa	lk 2 X Slope (%)	3.6
	N/A	Ramp inside XWalk1?	N/A	N/A	Ramp	inside XWalk2?	N/A
		Road Slope (%)	2.1	N/A	Clear	Space?	N/A
		Road X Slope (%)	2.1	N/A	Clear	Space to XWalk (in)	N/A
	N/A	Any Obstructions?	N/A	N/A	Storm	Grate/Utility Hazard?	N/A
		Obstruction Type			Storm	n Grate/Utility Type	
			N/A				N/A
				Yes	Surfa	ce Condition? (G/P)	Good
gab.				-

Remove & Replace Curb Ramp With Two New Directional Ramps or Equivalent.
