## Access Compliance Report Public Rights-of-Way (Curb Ramps)

Intersection ID: 50740 Main Street: LEE\_MARIE\_LN Cross Street: LYNN\_LEE\_CR Location: S

ADA ID: B2F5D70AE935 Ramp Type: PerpDiag Initial Pass/Fail: Fail Overall Compliance: No Severity Score: 46.25

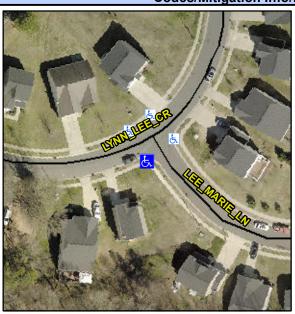
PROW/ADA:
Not Found, R304.5.1, R304.2.2,
R304.5.3

Compliance Description Data Compliance Description Data No Ramp Slope (%) N/A Ramp Length (in) 48.0 10.2 No Ramp XSlope (%) No Ramp Width (in) 44.0 8.7 N/A N/A Flare Type LT N/A Flare Type RT N/A N/A N/A N/A Flare Slope RT (%) N/A Flare Slope LT (%) N/A Flare Traversable LT? N/A N/A Flare Traversable RT? N/A N/A N/A N/A DWS Provided? N/A Landing Length (in) N/A Landing Width (in) N/A N/A **DWS Contrast?** N/A N/A N/A N/A Landing Slope (%) DWS Length (in) N/A N/A Landing X Slope (%) N/A N/A DWS Full Width? N/A N/A Landing Curb? (Y/N) N/A N/A DWS Offset (in) N/A N/A N/A Shared Landing? N/A **Gutter Ponding?** N/A N/A Gutter Slope (%) N/A N/A Gutter Lip Ht (in) N/A N/A Gutter X Slope (%) N/A N/A Painted X Walk1? No N/A Painted X Walk2? No X Walk 1 Direction To NE X Walk 2 Direction To N N/A N/A X Walk 1 Width (in) X Walk 2 Width (in) N/A X Walk 1 Slope (%) 0.9 X Walk 2 Slope (%) 6.3 X Walk 1 X Slope (%) 8.1 X Walk 2 X Slope (%) 2.8 N/A N/A N/A Ramp inside XWalk2? N/A Ramp inside XWalk1? Road Slope (%) 7.3 N/A Clear Space? N/A N/A Road X Slope (%) 5.1 Clear Space to XWalk (in) N/A N/A N/A Any Obstructions? N/A Storm Grate/Utility Hazard? N/A **Obstruction Type** Storm Grate/Utility Type N/A N/A Yes Surface Condition? (G/P) Good

Remove & Replace Curb Ramp With
Two New Directional Ramps or
Equivalent.
