Access Compliance Report

Public Rights-of-Way

(Curb Ramps)

Intersection ID: 50323	Main Street: SPRECO_LN	Cross Street: WALDON_PARK_LN	Location:	N
ADA ID: B3024C760058	Ramp Type: PerpDiag	Initial Pass/Fail: Fail	Overall Compliance: No	Severity Score: 37.5

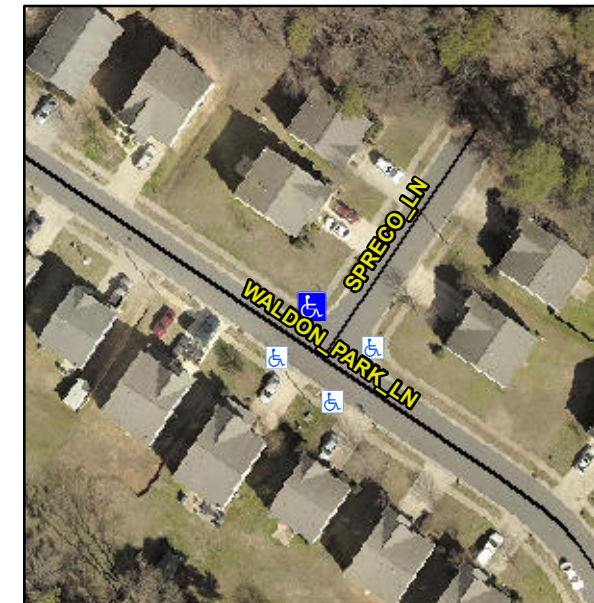
Not Found, R304.2.2, R304.5.3

Compliance	Description	Data	Compliance	Description	Data
N/A	Ramp Length (in)	47.0	No	Ramp Slope (%)	8.8
Yes	Ramp Width (in)	48.0	No	Ramp XSlope (%)	8.2
N/A	Flare Type LT	N/A	N/A	Flare Type RT	N/A
N/A	Flare Slope LT (%)	N/A	N/A	Flare Slope RT (%)	N/A
N/A	Flare Traversable LT?	N/A	N/A	Flare Traversable RT?	N/A
N/A	Landing Length (in)	N/A	N/A	DWS Provided?	N/A
N/A	Landing Width (in)	N/A	N/A	DWS Contrast?	N/A
N/A	Landing Slope (%)	N/A	N/A	DWS Length (in)	N/A
N/A	Landing X Slope (%)	N/A	N/A	DWS Full Width?	N/A
N/A	Landing Curb? (Y/N)	N/A	N/A	DWS Offset (in)	N/A
N/A	Shared Landing?	N/A			
N/A	Gutter Ponding?	N/A	N/A	Gutter Slope (%)	N/A
N/A	Gutter Lip Ht (in)	N/A	N/A	Gutter X Slope (%)	N/A
N/A	Painted X Walk1?	No	N/A	Painted X Walk2?	No
	X Walk 1 Direction	To SW		X Walk 2 Direction	To SE
N/A	X Walk 1 Width (in)	N/A	N/A	X Walk 2 Width (in)	N/A
	X Walk 1 Slope (%)	1.3		X Walk 2 Slope (%)	6.4
	X Walk 1 X Slope (%)	6.7		X Walk 2 X Slope (%)	2.9

Remove & Replace Curb Ramp With Two New Directional Ramps or Equivalent.
