# Access Compliance Report

## Public Rights-of-Way

| Intersection ID: 52299 | Main Street: LAKE_VISTA_LN | Cross Street: LINDA_VISTA_LN | Location: S |
| ADA ID: B3591E5C6A7E | Ramp Type: PerpDiag | Initial Pass/Fail: Fail | Overall Compliance: No |

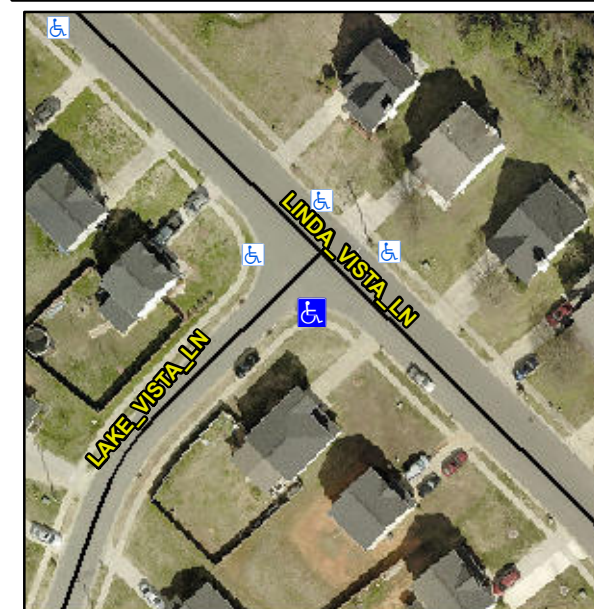
| Severity Score: 21.25 | | | |

**Not Found, R304.5.1, R304.2.2**

| Compliance | Description | Data | Compliance | Description | Data |
|---|---|---|---|---|---|
| N/A | Ramp Length (in) | 48.0 | No | Ramp Slope (%) | 10.8 |
| No | Ramp Width (in) | 47.0 | Yes | Ramp XSlope (%) | 1.0 |

**Remove & Replace Curb Ramp With Two New Directional Ramps or Equivalent.**

Total Cost: \$ 3200.00
