Access Compliance Report

Public Rights-of-Way

(Curb Ramps)

Intersection ID: 12695	Main Street: S_CALDWELL_ST	Cross Street: E TRADE ST	Location: NW
ADA ID: B36B97D2715A	Ramp Type: Combination1	Initial Pass/Fail: Fail	Overall Compliance: No
			Severity Score: 33.75

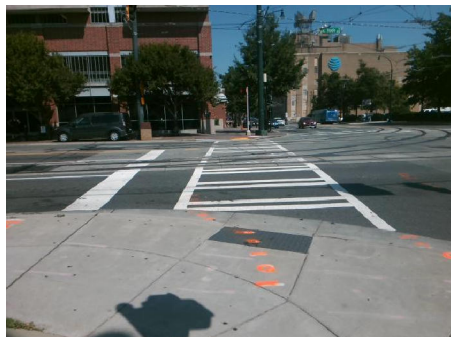
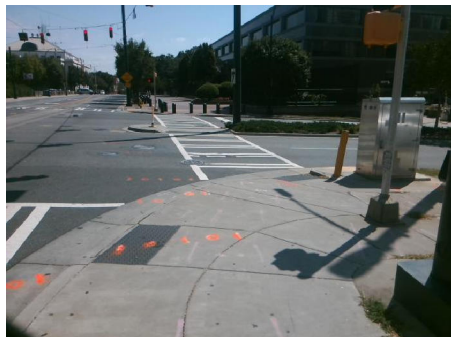
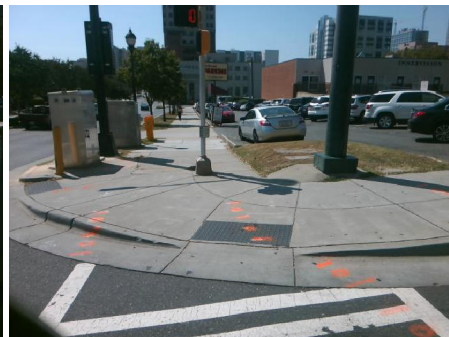
Not Found, R304.5.1, R304.5.3, R304.3.2

Compliance	Description	Data	Compliance	Description	Data
N/A	Ramp Length LT (in)	22.0	N/A	Ramp Length RT (in)	34.0
Yes	Ramp Width LT (in)	56.0	Yes	Ramp Width RT (in)	58.0
Yes	Ramp Slope LT (%)	7.3	No	Ramp Slope RT (%)	9.7
No	Ramp XSlope LT (%)	3.5	Yes	Ramp XSlope RT (%)	0.1
N/A	Ramp Length (in)	50.0	Yes	Ramp Slope (%)	5.4
No	Ramp Width (in)	47.0	No	Ramp XSlope (%)	5.4
N/A	Flare Type LT	N/A	N/A	Flare Type RT	N/A
N/A	Flare Slope LT (%)	N/A	N/A	Flare Slope RT (%)	N/A
N/A	Flare Traversable LT?	N/A	N/A	Flare Traversable RT?	N/A
N/A	Landing Length (in)	N/A	N/A	DWS Provided?	N/A
N/A	Landing Width (in)	N/A	N/A	DWS Contrast?	N/A
N/A	Landing Slope (%)	N/A	N/A	DWS Length (in)	N/A
N/A	Landing X Slope (%)	N/A	N/A	DWS Full Width?	N/A
N/A	Landing Curb? (Y/N)	N/A	N/A	DWS Offset (in)	N/A
N/A	Shared Landing?	N/A			
N/A	Gutter Ponding?	N/A	N/A	Gutter Slope (%)	N/A
N/A	Gutter Lip Ht (in)	N/A	N/A	Gutter X Slope (%)	N/A
N/A	Painted X Walk1?	Yes	N/A	Painted X Walk2?	N/A

Remove & Replace Entire Ramp.
