# Access Compliance Report

## Public Rights-of-Way

### (Curb Ramps)

| Intersection ID: 12779 | Main Street: E_TRADE_ST | Cross Street: S_DAVIDSON_ST | Location: | N |

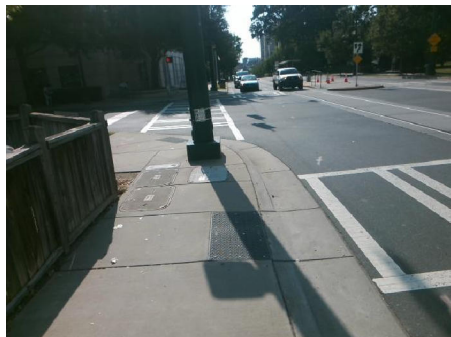
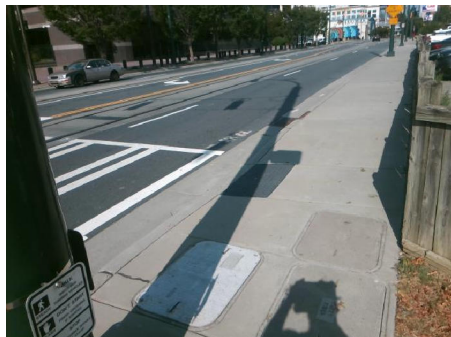
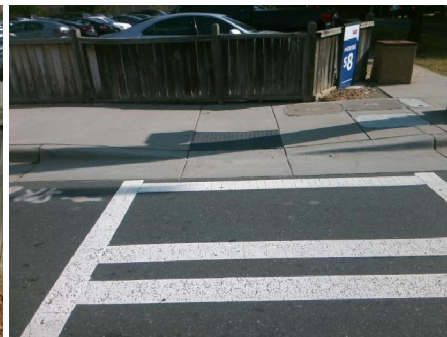
| ADA ID: B39F0FFE4D1B | Ramp Type: Combination2 | Initial Pass/Fail: Pass | Overall Compliance: No | Severity Score: 0.25 |

**Not Found, R304.5.3, R304.2.1, R304.2.2-Perp, R304.3.2-Para**

| Compliance | Description | Data | Compliance | Description | Data |
|---|---|---|---|---|---|
| No | Ramp XSlope LT (%) | 4.5 | N/A | Ramp XSlope RT (%) | N/A |
| Yes | Ramp Width (in) | 48.0 | No | Ramp XSlope (%) | 3.7 |
| No | Landing Length (in) | 54.0 | Yes | DWS Provided? | Yes |
| No | Landing Slope (%) | 4.7 | Yes | DWS Length (in) | 24.0 |

**Remove & Replace Entire Ramp.**
