## **Access Compliance Report Public Rights-of-Way** (Curb Ramps)

Intersection ID: 53960 Main Street: DENBUR DR **Cross Street: MAGNOLIA LILY AV** Location: S Initial Pass/Fail: Fail **Overall Compliance: No** ADA ID: B409E894AD25 Ramp Type: Combination2 **Severity Score:** 8.75

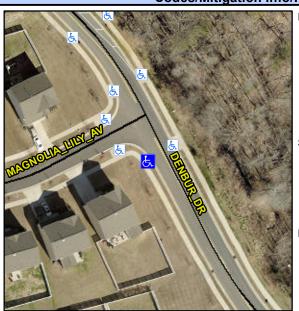
Street 1 Name None **DENBUR DR** Stop Condition-Street 1 Street 2 Name N/A Stop Condition-Street 2 N/A Possible Solutions: Compliance Description N/A Remove & Replace Entire Ramp. N/A N/A N/A N/A No Surveyor Notes: N/A LT RP < 5% N/A N/A N/A N/A PROW/ADA: N/A Not Found, R304.5.1 N/A N/A N/A N/A N/A N/A
