# Access Compliance Report

## Public Rights-of-Way

### (Curb Ramps)

| Intersection ID: 45499 | Main Street: BUGGY_HORSE_RD | Cross Street: GRASSY_CROPS_RD | Location: S |

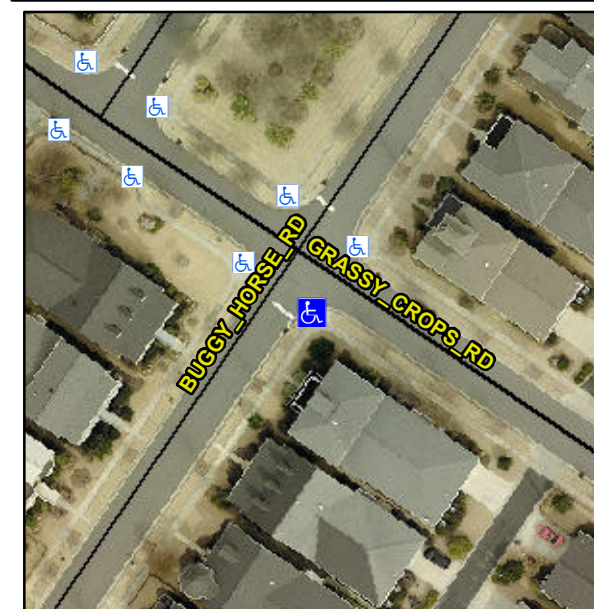
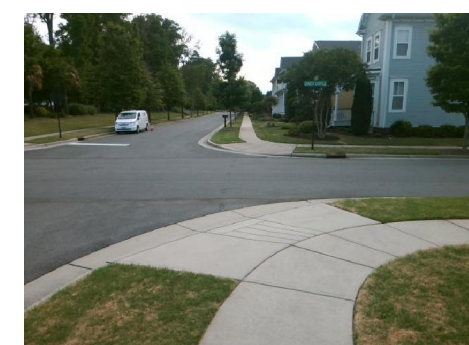
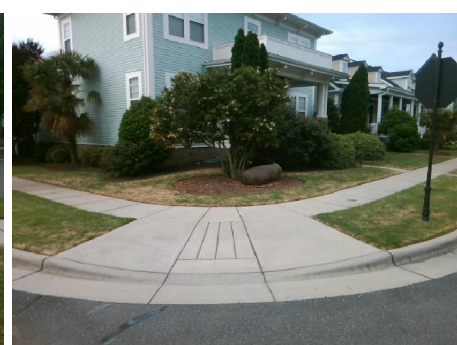
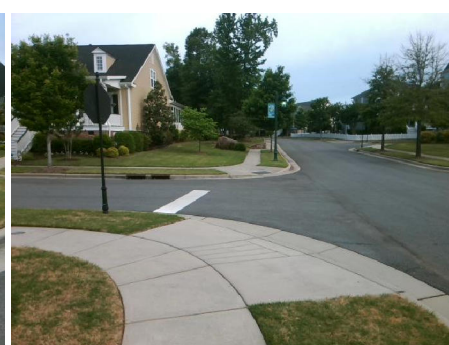
| ADA ID: B421FC95740F | Ramp Type: PerpDiag | Initial Pass/Fail: Fail | Overall Compliance: No |

**Not Found, R304.5.1, R304.2.2**

| Compliance | Description | Data | Compliance | Description | Data |
|---|---|---|---|---|---|
| N/A | Ramp Length (in) | 72.0 | No | Ramp Slope (%) | 13.0 |
| No | Ramp Width (in) | 32.0 | Yes | Ramp XSlope (%) | 1.4 |

**Remove & Replace Curb Ramp With Two New Directional Ramps or Equivalent.**
