Access Compliance Report

Public Rights-of-Way

(Curb Ramps)

| Intersection ID: 7593 | Main Street: BANNISTER_PL | Cross Street: YUMA_ST | Location: NE |

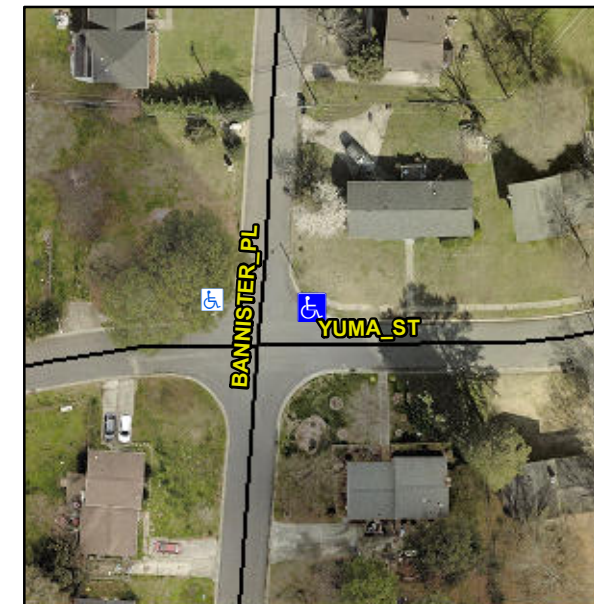
| ADA ID: B449B1A958BB | Ramp Type: Combination2 | Initial Pass/Fail: Fail | Overall Compliance: No |

LT RP < 5%

Not Found, R304.5.1, R304.5.3

| Compliance | Description | Data | Compliance | Description | Data |
|---|---|---|---|---|---|
| N/A | Ramp XSlope LT (%) | 1.6 | No | Ramp XSlope RT (%) | 2.7 |
| No | Ramp Width (in) | 37.5 | No | Ramp XSlope (%) | 3.0 |

Remove & Replace Entire Ramp.
