## **Access Compliance Report Public Rights-of-Way** (Curb Ramps)

Intersection ID: 47584 Main Street: GLENBURN LN **Cross Street: EVANTON LOCH RD** Location: SW **ADA ID: B4C5BB268F6E** Ramp Type: BlendTrans1 Initial Pass/Fail: Fail **Overall Compliance: No Severity Score:** 1.25

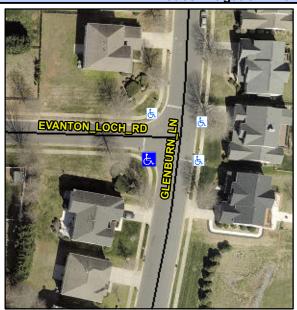
Data	Compliance Description		Data
N/A	Ramp Length (in)	47.0	Yes	BlendTrans Slope (%)	4.7
Yes	Ramp Width (in)	48.0	No	BlendTrans XSlope (%)	4.6
N/A	Flare Type LT	N/A	N/A	Flare Type RT	N/A
N/A	Flare Slope LT (%)	N/A	N/A	Flare Slope RT (%)	N/A
N/A	Flare Traversable LT?	N/A	N/A	Flare Traversable RT?	N/A
N/A	Landing Length (in)	N/A	N/A	DWS Provided?	N/A
N/A	Landing Width (in)	N/A	N/A	DWS Contrast?	N/A
N/A	Landing Slope (%)	N/A	N/A	DWS Length (in)	N/A
N/A	Landing X Slope (%)	N/A	N/A	DWS Full Width?	N/A
N/A	Landing Curb? (Y/N)	N/A	N/A	DWS Offset (in)	N/A
N/A	Shared Landing?	N/A			
N/A	Gutter Ponding?	N/A	N/A	Gutter Slope (%)	N/A
N/A	Gutter Lip Ht (in)	N/A	N/A	Gutter X Slope (%)	N/A
N/A	Painted X Walk1?	No	N/A	Painted X Walk2?	No
	X Walk 1 Direction	To E		X Walk 2 Direction	To N
	X Walk 1 Width (in)	N/A		X Walk 2 Width (in)	N/A
	X Walk 1 Slope (%)	2.5		X Walk 2 Slope (%)	2.6
	X Walk 1 X Slope (%)	2.6		X Walk 2 X Slope (%)	0.8

N/A	Ramp inside XWalk1?	N/A	N/A	Ramp inside XWalk2?	N/A
	Road Slope (%)	3.2		Clear Space?	N/A
	Road X Slope (%)	2.7	N/A	Clear Space to XWalk (in)	N/A
N/A	Any Obstructions?	N/A	N/A	Storm Grate/Utility Hazard?	N/A
	Obstruction Type			Storm Grate/Utility Type	
		N/A	l		N/A
			Yes	Surface Condition? (G/P)	Good
			No	Curb Slope (%)	6.7

Possible Solutions: **Remove & Replace Curb Ramp With** Two New Directional Ramps or Equivalent. Surveyor Notes: N/A PROW/ADA: Not Found, R304.5.3
