Access Compliance Report Public Rights-of-Way (Curb Ramps)

Intersection ID: 31447 Main Street: RIDING_HILL_AV Cross Street: GLENLUCE_AV Location: N

ADA ID: B52D627CF5DD Ramp Type: Perp Initial Pass/Fail: Fail Overall Compliance: No Severity Score: 33.75

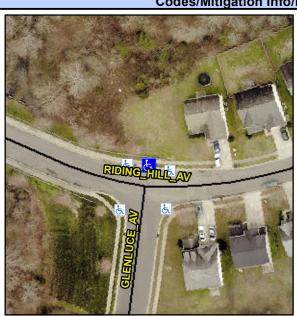
•			
Field Measurements/Component Compliance							
Comp	Compliance Description Data		Compliance Description		Data		
N/A	Ramp Length (in)	48.0	Yes	Ramp Slope (%)	5.4		
No	Ramp Width (in)	45.5	No	Ramp XSlope (%)	7.8		
N/A	Flare Type LT	N/A	N/A	Flare Type RT	N/A		
N/A	Flare Slope LT (%)	N/A	N/A	Flare Slope RT (%)	N/A		
N/A	Flare Traversable LT?	N/A	N/A	Flare Traversable RT?	N/A		
N/A	Landing Length (in)	N/A	N/A	DWS Provided?	N/A		
N/A	Landing Width (in)	N/A	N/A	DWS Contrast?	N/A		
N/A	Landing Slope (%)	N/A	N/A	DWS Length (in)	N/A		
N/A	Landing X Slope (%)	N/A	N/A	DWS Full Width?	N/A		
N/A	Landing Curb? (Y/N)	N/A	N/A	DWS Offset (in)	N/A		
N/A	Shared Landing?	N/A					
N/A	Gutter Ponding?	N/A	N/A	Gutter Slope (%)	N/A		
N/A	Gutter Lip Ht (in)	N/A	N/A	Gutter X Slope (%)	N/A		
N/A	Painted X Walk1?	No	N/A	Painted X Walk2?	N/A		
	X Walk 1 Direction	To SE		X Walk 2 Direction	N/A		
N/A	X Walk 1 Width (in)	N/A	N/A	X Walk 2 Width (in)	N/A

X Walk 1 Slope (%)	0.6		X Walk 2 Slope (%)	N/A		
	X Walk 1 X Slope (%)	6.4		X Walk 2 X Slope (%)	N/A		
N/A	Ramp inside XWalk1?	N/A	N/A	Ramp inside XWalk2?	N/A		
	Road Slope (%)	N/A	N/A	Clear Space?	N/A		
	Road X Slope (%)	N/A	N/A	Clear Space to XWalk (in)	N/A		
N/A	Any Obstructions?	N/A	N/A	Storm Grate/Utility Hazard?	N/A		
	Obstruction Type		l	Storm Grate/Utility Type			
		N/A			N/A		
			Yes	Surface Condition? (G/P)	Good

Possible Solutions:				
Remove & Replace Entire Ramp.				
	ı			
Surveyor Notes:				
N/A	ı			
	ı			
	ı			
PROW/ADA:				
Not Found, R304.5.1, R304.5.3	,			
	,			
	ı			
	ı
