# Access Compliance Report

## Public Rights-of-Way

### (Curb Ramps)

Intersection ID: 52467	Main Street: ACQUINAS_PL	Cross Street: ST_JOHN_LN	Location: W
ADA ID: B59F58DFA1CC	Ramp Type: BlendTrans1	Initial Pass/Fail: Fail	Overall Compliance: No
Severity Score: 12.5			
Codes/Mitigation Info/Possible Solution		Field Measurements/Component Compliance

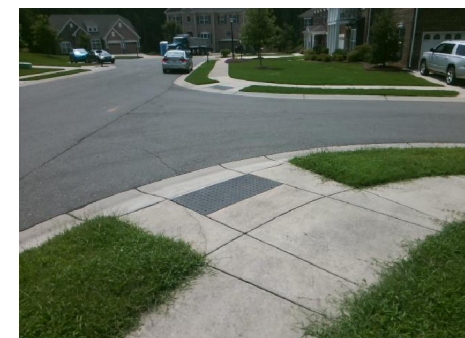
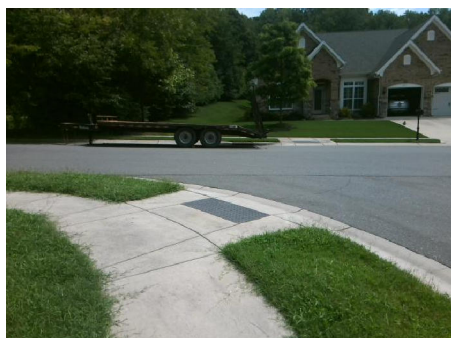
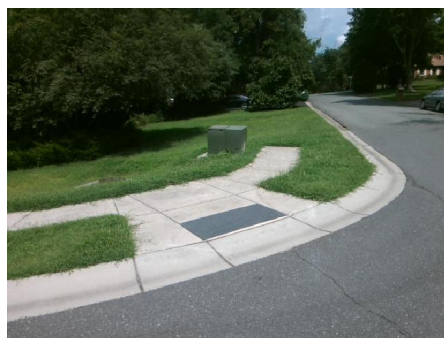
**Not Found, R304.5.3**

Compliance	Description	Data	Compliance	Description	Data
N/A	Ramp Length (in)	47.0	Yes	BlendTrans Slope (%)	3.8
Yes	Ramp Width (in)	48.0	No	BlendTrans XSlope (%)	5.2
N/A	Flare Type LT	N/A	N/A	Flare Type RT	N/A
N/A	Flare Slope LT (%)	N/A	N/A	Flare Slope RT (%)	N/A
N/A	Flare Traversable LT?	N/A	N/A	Flare Traversable RT?	N/A
N/A	Landing Length (in)	N/A	N/A	DWS Provided?	N/A
N/A	Landing Width (in)	N/A	N/A	DWS Contrast?	N/A
N/A	Landing Slope (%)	N/A	N/A	DWS Length (in)	N/A
N/A	Landing X Slope (%)	N/A	N/A	DWS Full Width?	N/A
N/A	Landing Curb? (Y/N)	N/A	N/A	DWS Offset (in)	N/A
N/A	Shared Landing?	N/A			
N/A	Gutter Ponding?	N/A	N/A	Gutter Slope (%)	N/A
N/A	Gutter Lip Ht (in)	N/A	N/A	Gutter X Slope (%)	N/A
N/A	Painted X Walk1?	No	N/A	Painted X Walk2?	No
	X Walk 1 Direction	To S		X Walk 2 Direction	To E
	X Walk 1 Width (in)	N/A		X Walk 2 Width (in)	N/A
	X Walk 1 Slope (%)	5.2		X Walk 2 Slope (%)	1.1
	X Walk 1 X Slope (%)	2.8		X Walk 2 X Slope (%)	5.2

N/A	Ramp inside XWalk1?	N/A	N/A	Ramp inside XWalk2?	N/A
	Road Slope (%)	4.7		Clear Space?	N/A
	Road X Slope (%)	1.8	N/A	Clear Space to XWalk (in)	N/A
N/A	Any Obstructions?	N/A	N/A	Storm Grate/Utility Hazard?	N/A
	Obstruction Type			Storm Grate/Utility Type	
		N/A			N/A
			Yes	Surface Condition? (G/P)	Good
			No	Curb Slope (%)	10.2

**Remove & Replace Curb Ramp With Two New Directional Ramps or Equivalent.**
