Access Compliance Report Public Rights-of-Way (Curb Ramps)

Intersection ID: 31459 Main Street: BOBTERRY CT Cross Street: BOMAR DR Location: NE **Overall Compliance: No** ADA ID: B5C536FCE55B Ramp Type: PerpDiag Initial Pass/Fail: Fail Severity Score: 33.75

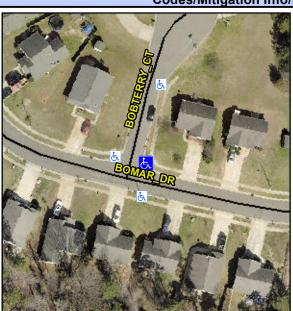
47.5 No

Stop Condition-Street 2	StopSign					X Walk 1 X Slope (%)	2.8		X Walk 2 X Slope (%)	7.4
Street 2 Name	BOMAR DR				N/A	Ramp inside XWalk1?	N/A	N/A	Ramp inside XWalk2?	N/A
Stop Condition-Street 1	None					Road Slope (%)	4.2	N/A	Clear Space?	N/A
						Road X Slope (%)	7.9	N/A	Clear Space to XWalk (in)	N/A
					N/A	Any Obstructions?	N/A	N/A	Storm Grate/Utility Hazard?	N/A
		Total Cost:	\$	3200.00		Obstruction Type		l	Storm Grate/Utility Type	
							N/A			N/A
								Yes	Surface Condition? (G/P)	Good
HHI

Remove & Replace Curb Ramp With Two New Directional Ramps or Equivalent.
