Access Compliance Report Public Rights-of-Way (Curb Ramps)

Intersection ID: 53746 Main Street: SPRINGWOOD_ESTATE_DR Cross Street: CANTERBURY_CASTLE_DR Location: SE

ADA ID: B63BD3FBE7B6 Ramp Type: Perp Initial Pass/Fail: Fail Overall Compliance: No Severity Score: 33.75

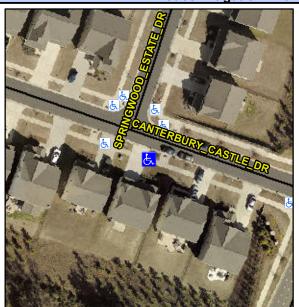
Comp	liance Description	Data	Comp	liance	Description	Data
N/A	Ramp Length (in)	96.0	No	Ramp	Slope (%)	9.4
No	Ramp Width (in)	47.0	No	Ramp	XSlope (%)	5.6
N/A	Flare Type LT	N/A	N/A	Flare	Type RT	N/A
N/A	Flare Slope LT (%)	N/A	N/A	Flare	Slope RT (%)	N/A
N/A	Flare Traversable LT?	N/A	N/A	Flare	Traversable RT?	N/A
N/A	Landing Length (in)	N/A	N/A	DWS	Provided?	N/A
N/A	Landing Width (in)	N/A	N/A	DWS	Contrast?	N/A
N/A	Landing Slope (%)	N/A	N/A	DWS	Length (in)	N/A
N/A	Landing X Slope (%)	N/A	N/A	DWS	Full Width?	N/A
N/A	Landing Curb? (Y/N)	N/A	N/A	DWS	Offset (in)	N/A
N/A	Shared Landing?	N/A				
N/A	Gutter Ponding?	N/A	N/A	Gutte	r Slope (%)	N/A
N/A	Gutter Lip Ht (in)	N/A	N/A	Gutte	r X Slope (%)	N/A
N/A	Painted X Walk1?	No	N/A	Paint	ed X Walk2?	N/A
	X Walk 1 Direction	To NE		X Wa	lk 2 Direction	N/A
N/A	X Walk 1 Width (in)	N/A	N/A	X Wa	lk 2 Width (in)	N/A
	X Walk 1 Slope (%)	2.8		X Wa	lk 2 Slope (%)	N/A
	X Walk 1 X Slope (%)	4.2		X Wa	lk 2 X Slope (%)	N/A

PUSSIBLE SUIULIUII	
Possible Solutions:	<u>c</u>
Remove & Replace Entire Ramp.	N
	N
	N/
	N
	N
	N
Surveyor Notes:	N
N/A	N
	N
	N
	N
PROW/ADA:	N
R304.5.1, R304.2.2, R304.5.3	N/
	N
	N
	N
