Access Compliance Report

Public Rights-of-Way

(Curb Ramps)

Intersection ID: 10290	Main Street: LIMA_AV	Cross Street: ROSLYN_AV	Location: SW
ADA ID: B63DF2E8A5FE	Ramp Type: PerpDiag	Initial Pass/Fail: Fail	Overall Compliance: No
			Severity Score: 21.25

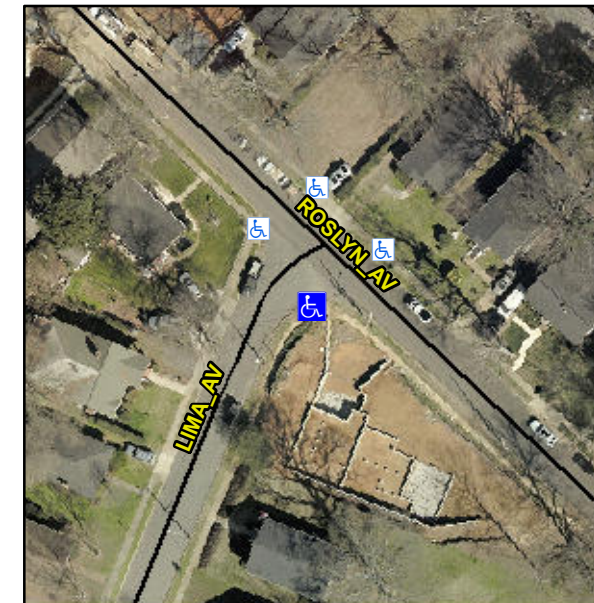
Not Found, R304.5.1, R304.2.2

Compliance	Description	Data	Compliance	Description	Data
N/A	Ramp Length (in)	48.5	No	Ramp Slope (%)	10.2
No	Ramp Width (in)	40.5	Yes	Ramp XSlope (%)	0.6
N/A	Flare Type LT	N/A	N/A	Flare Type RT	N/A
N/A	Flare Slope LT (%)	N/A	N/A	Flare Slope RT (%)	N/A
N/A	Flare Traversable LT?	N/A	N/A	Flare Traversable RT?	N/A
N/A	Landing Length (in)	N/A	N/A	DWS Provided?	N/A
N/A	Landing Width (in)	N/A	N/A	DWS Contrast?	N/A
N/A	Landing Slope (%)	N/A	N/A	DWS Length (in)	N/A
N/A	Landing X Slope (%)	N/A	N/A	DWS Full Width?	N/A
N/A	Landing Curb? (Y/N)	N/A	N/A	DWS Offset (in)	N/A
N/A	Shared Landing?	N/A			
N/A	Gutter Ponding?	N/A	N/A	Gutter Slope (%)	N/A
N/A	Gutter Lip Ht (in)	N/A	N/A	Gutter X Slope (%)	N/A
N/A	Painted X Walk1?	No	N/A	Painted X Walk2?	No
	X Walk 1 Direction	To E		X Walk 2 Direction	To N
N/A	X Walk 1 Width (in)	N/A	N/A	X Walk 2 Width (in)	N/A
	X Walk 1 Slope (%)	0.2		X Walk 2 Slope (%)	0.7
	X Walk 1 X Slope (%)	1.9		X Walk 2 X Slope (%)	2.3

Remove & Replace Curb Ramp With Two New Directional Ramps or Equivalent.
