# Access Compliance Report

## Public Rights-of-Way

### (Curb Ramps)

| Intersection ID: 5704 | Main Street: W W T HARRIS BV | Cross Street: N TRYON ST | Location: S |

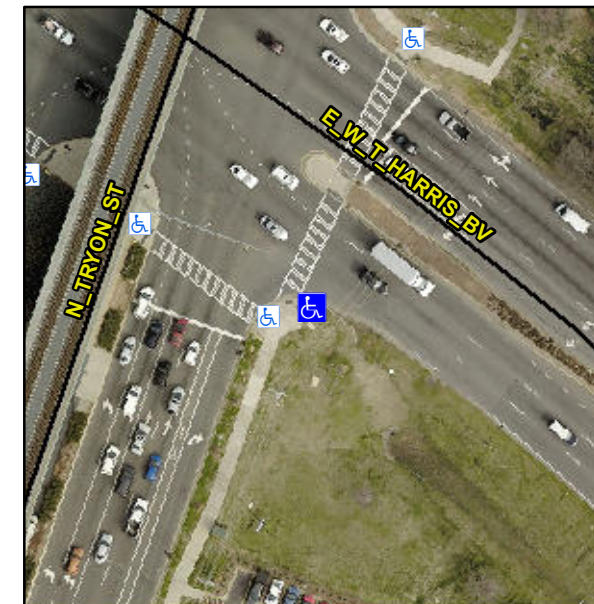
| ADA ID: B68D3312823E | Ramp Type: Perp | Initial Pass/Fail: Fail | Overall Compliance: No |

**Not Found, R304.2.2**

| Compliance | Description | Data | Compliance | Description | Data |
|---|---|---|---|---|---|
| N/A | Ramp Length (in) | 96.0 | No | Ramp Slope (%) | 9.7 |
| N/A | Gutter Ponding? | Yes | N/A | Gutter Slope (%) | N/A |

**Remove & Replace Entire Ramp.**
