Access Compliance Report

Public Rights-of-Way

| Intersection ID: 8739 | Main Street: N_TRYON_ST | Cross Street: W_EASTWAY_DR | Location: | NW |
| ADA ID: B6C3301B5DB5 | Ramp Type: Para | Initial Pass/Fail: Fail | Overall Compliance: No | Severity Score: 25 |

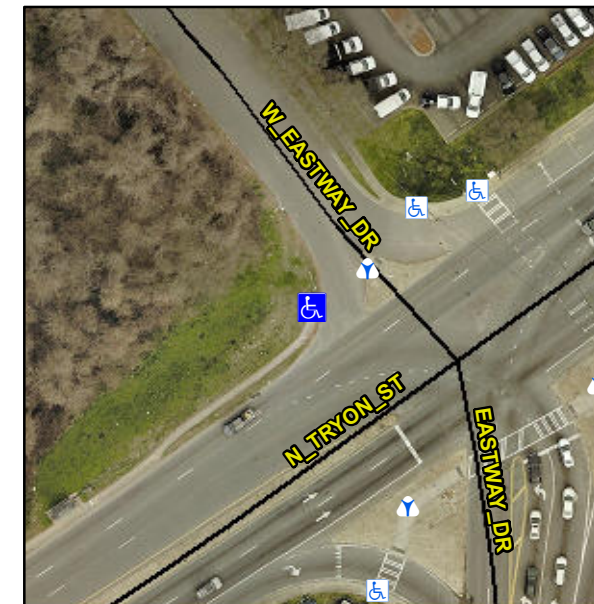
R304.3.2

| Compliance | Description | Data | Compliance | Description | Data |
|---|---|---|---|---|---|
| No | Ramp Slope LT (%) | 12.0 | Yes | Ramp Slope RT (%) | 6.2 |

Possible Solutions:

Remove & Replace Entire Ramp.
