Access Compliance Report Public Rights-of-Way (Curb Ramps)

Intersection ID: 21209Main Street: GALLERIA_BVCross Street: SARDIS_RD_NORTHLocation:SEADA ID: B6FC80582E8CRamp Type: ParaInitial Pass/Fail: FailOverall Compliance: NoSeverity Score:35

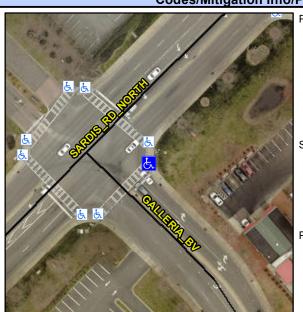
LT RP < 5%

R304.5.1, R304.5.3, R304.3.2

Field Measurements/Component Compliance					
Compliance Description		Data	Compliance Description		Data
N/A	Ramp Length LT (in)	60.0	N/A	Ramp Length RT (in)	67.0
No	Ramp Width LT (in)	37.0	No	Ramp Width RT (in)	36.0
Yes	Ramp Slope LT (%)	2.8	No	Ramp Slope RT (%)	12.0
No	Ramp XSlope LT (%)	2.8	No	Ramp XSlope RT (%)	3.2
N/A	Landing Length (in)	N/A	N/A	DWS Provided?	N/A
N/A	Landing Width (in)	N/A	N/A	DWS Contrast?	N/A
N/A	Landing Slope (%)	N/A	N/A	DWS Length (in)	N/A
N/A	Landing X Slope (%)	N/A	N/A	DWS Full Width?	N/A
N/A	Landing Curb? (Y/N)	N/A	N/A	DWS Offset (in)	N/A
N/A	Shared Landing?	N/A			
N/A	Gutter Ponding?	N/A	N/A	Gutter Slope (%)	N/A
N/A	Gutter Lip Ht (in)	N/A	N/A	Gutter X Slope (%)	N/A
N/A	Painted X Walk1?	Yes	N/A	Painted X Walk2?	N/A
	X Walk 1 Direction	To SW		X Walk 2 Direction	N/A
N/A	X Walk 1 Width (in)	92.0	N/A	X Walk 2 Width (in)	N/A
	X Walk 1 Slope (%)	2.2		X Walk 2 Slope (%)	N/A
	X Walk 1 X Slope (%)	1.6		X Walk 2 X Slope (%)	N/A

N/A	Ramp inside XWalk1?	Yes	N/A	Ramp inside XWalk2?	N/A
	Road Slope (%)	N/A	N/A	Clear Space?	N/A
	Road X Slope (%)	N/A	N/A	Clear Space to XWalk (in)	N/A
N/A	Any Obstructions?	N/A	N/A	Storm Grate/Utility Hazard?	N/A
	Obstruction Type			Storm Grate/Utility Type	
		N/A			N/A
			Yes	Surface Condition? (G/P)	Good
			N/A	Curb Slope (%)	3.3
	AND SECRET				
THE RESERVE AND ADDRESS OF THE PARTY OF THE	The second secon

Remove & Replace Entire Ramp.
