# Access Compliance Report

## Public Rights-of-Way

### (Curb Ramps)

Intersection ID: 14400		Main Street: BERKELEY_AV		Cross Street: DILWORTH_RD		Location: NE											
ADA ID: B7BFCC57E6B8		Ramp Type: Directional1		Initial Pass/Fail: Fail		Overall Compliance: No		Severity Score: 10									
Codes/Mitigation Info/Possible Solution				Field Measurements/Component Compliance

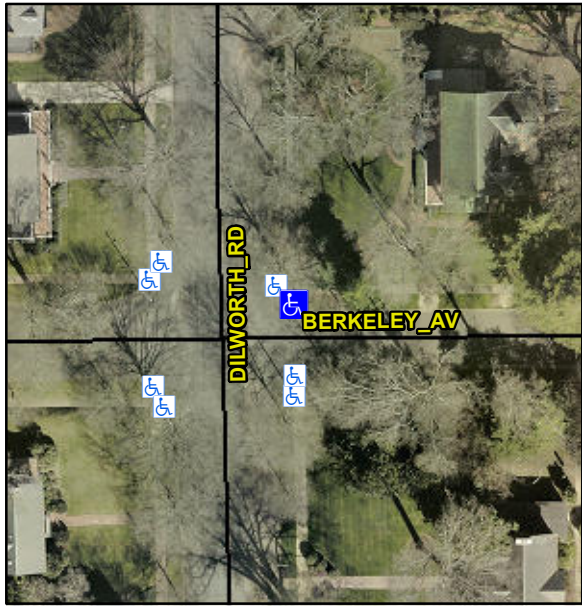
Possible Solutions:		Compliance		Description		Data		Compliance		Description		Data	
				Remove & Replace Entire Ramp.		N/A		Ramp Length (in)		75.0		N/A		Grade Break?		N/A	
Surveyor Notes:				N/A		No		Ramp Width (in)		43.0		N/A		Grade Break Slope (%)		0.0	
						Yes		Ramp Slope (%)		8.0		N/A		Grade Break XSlope (%)		0.0	
PROW/ADA:				R304.5.1, R304.5.3		No		Ramp XSlope (%)		3.9							
						N/A		Flare Type LT		N/A		N/A		Flare Type RT		N/A	
Street 1 Name				BERKELEY AV		N/A		Flare Slope LT (%)		N/A		N/A		Flare Slope RT (%)		0.0	
				StopSign				N/A		Flare Traversable LT?		N/A		N/A		Flare Traversable RT?
