# Access Compliance Report

## Public Rights-of-Way

### (Curb Ramps)

Intersection ID: 23869	Main Street: STERLING_LN	Cross Street: YANDLE_LN	Location: S
ADA ID: B826CED2EFC3	Ramp Type: PerpDiag	Initial Pass/Fail: Fail	Overall Compliance: No
Severity Score: 48.75			
Codes/Mitigation Info/Possible Solution		Field Measurements/Component Compliance

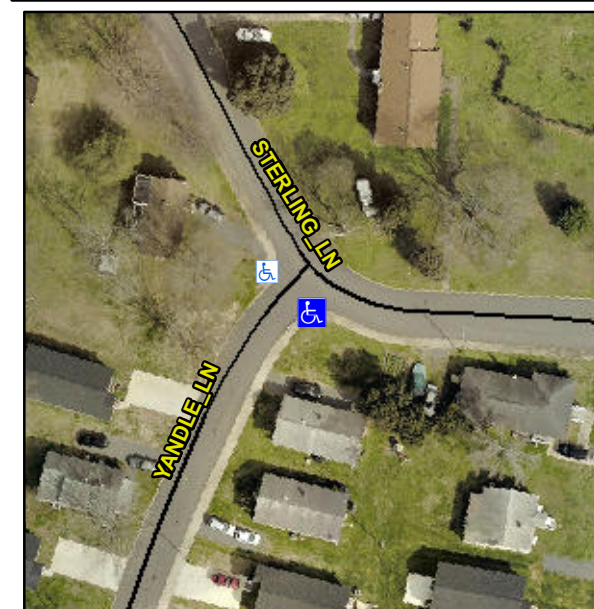
**Not Found, R304.5.1, R304.2.2, R304.5.3**

Compliance	Description	Data	Compliance	Description	Data
N/A	Ramp Length (in)	57.0	No	Ramp Slope (%)	10.4
No	Ramp Width (in)	28.0	No	Ramp XSlope (%)	4.5
N/A	Flare Type LT	N/A	N/A	Flare Type RT	N/A
N/A	Flare Slope LT (%)	N/A	N/A	Flare Slope RT (%)	N/A
N/A	Flare Traversable LT?	N/A	N/A	Flare Traversable RT?	N/A
N/A	Landing Length (in)	N/A	N/A	DWS Provided?	N/A
N/A	Landing Width (in)	N/A	N/A	DWS Contrast?	N/A
N/A	Landing Slope (%)	N/A	N/A	DWS Length (in)	N/A
N/A	Landing X Slope (%)	N/A	N/A	DWS Full Width?	N/A
N/A	Landing Curb? (Y/N)	N/A	N/A	DWS Offset (in)	N/A
N/A	Shared Landing?	N/A			
N/A	Gutter Ponding?	N/A	N/A	Gutter Slope (%)	N/A
N/A	Gutter Lip Ht (in)	N/A	N/A	Gutter X Slope (%)	N/A
N/A	Painted X Walk1?	No	N/A	Painted X Walk2?	No
	X Walk 1 Direction	To NE		X Walk 2 Direction	To NW
N/A	X Walk 1 Width (in)	N/A	N/A	X Walk 2 Width (in)	N/A
	X Walk 1 Slope (%)	5.4		X Walk 2 Slope (%)	0.4
	X Walk 1 X Slope (%)	1.8		X Walk 2 X Slope (%)	6.4

N/A	Ramp inside XWalk1?	N/A	N/A	Ramp inside XWalk2?	N/A
	Road Slope (%)	3.2	N/A	Clear Space?	N/A
	Road X Slope (%)	3.4	N/A	Clear Space to XWalk (in)	N/A
N/A	Any Obstructions?	N/A	N/A	Storm Grate/Utility Hazard?	N/A
	Obstruction Type			Storm Grate/Utility Type	
		N/A			N/A
			Yes	Surface Condition? (G/P)	Good

**Remove & Replace Curb Ramp With Two New Directional Ramps or Equivalent.**

Total Cost: \$ 3200.00
